# North Level District IDB: Nene Washes Morton's Leam Aquatic Weed Control, August 2018

Martin Redding, Project Engineer, North Level IDB 15/03/2019

# North Level District IDB: Morton's Leam Aquatic Weed Control between Stanground Sluice & Little Bridge August 15-17<sup>th</sup> 2018

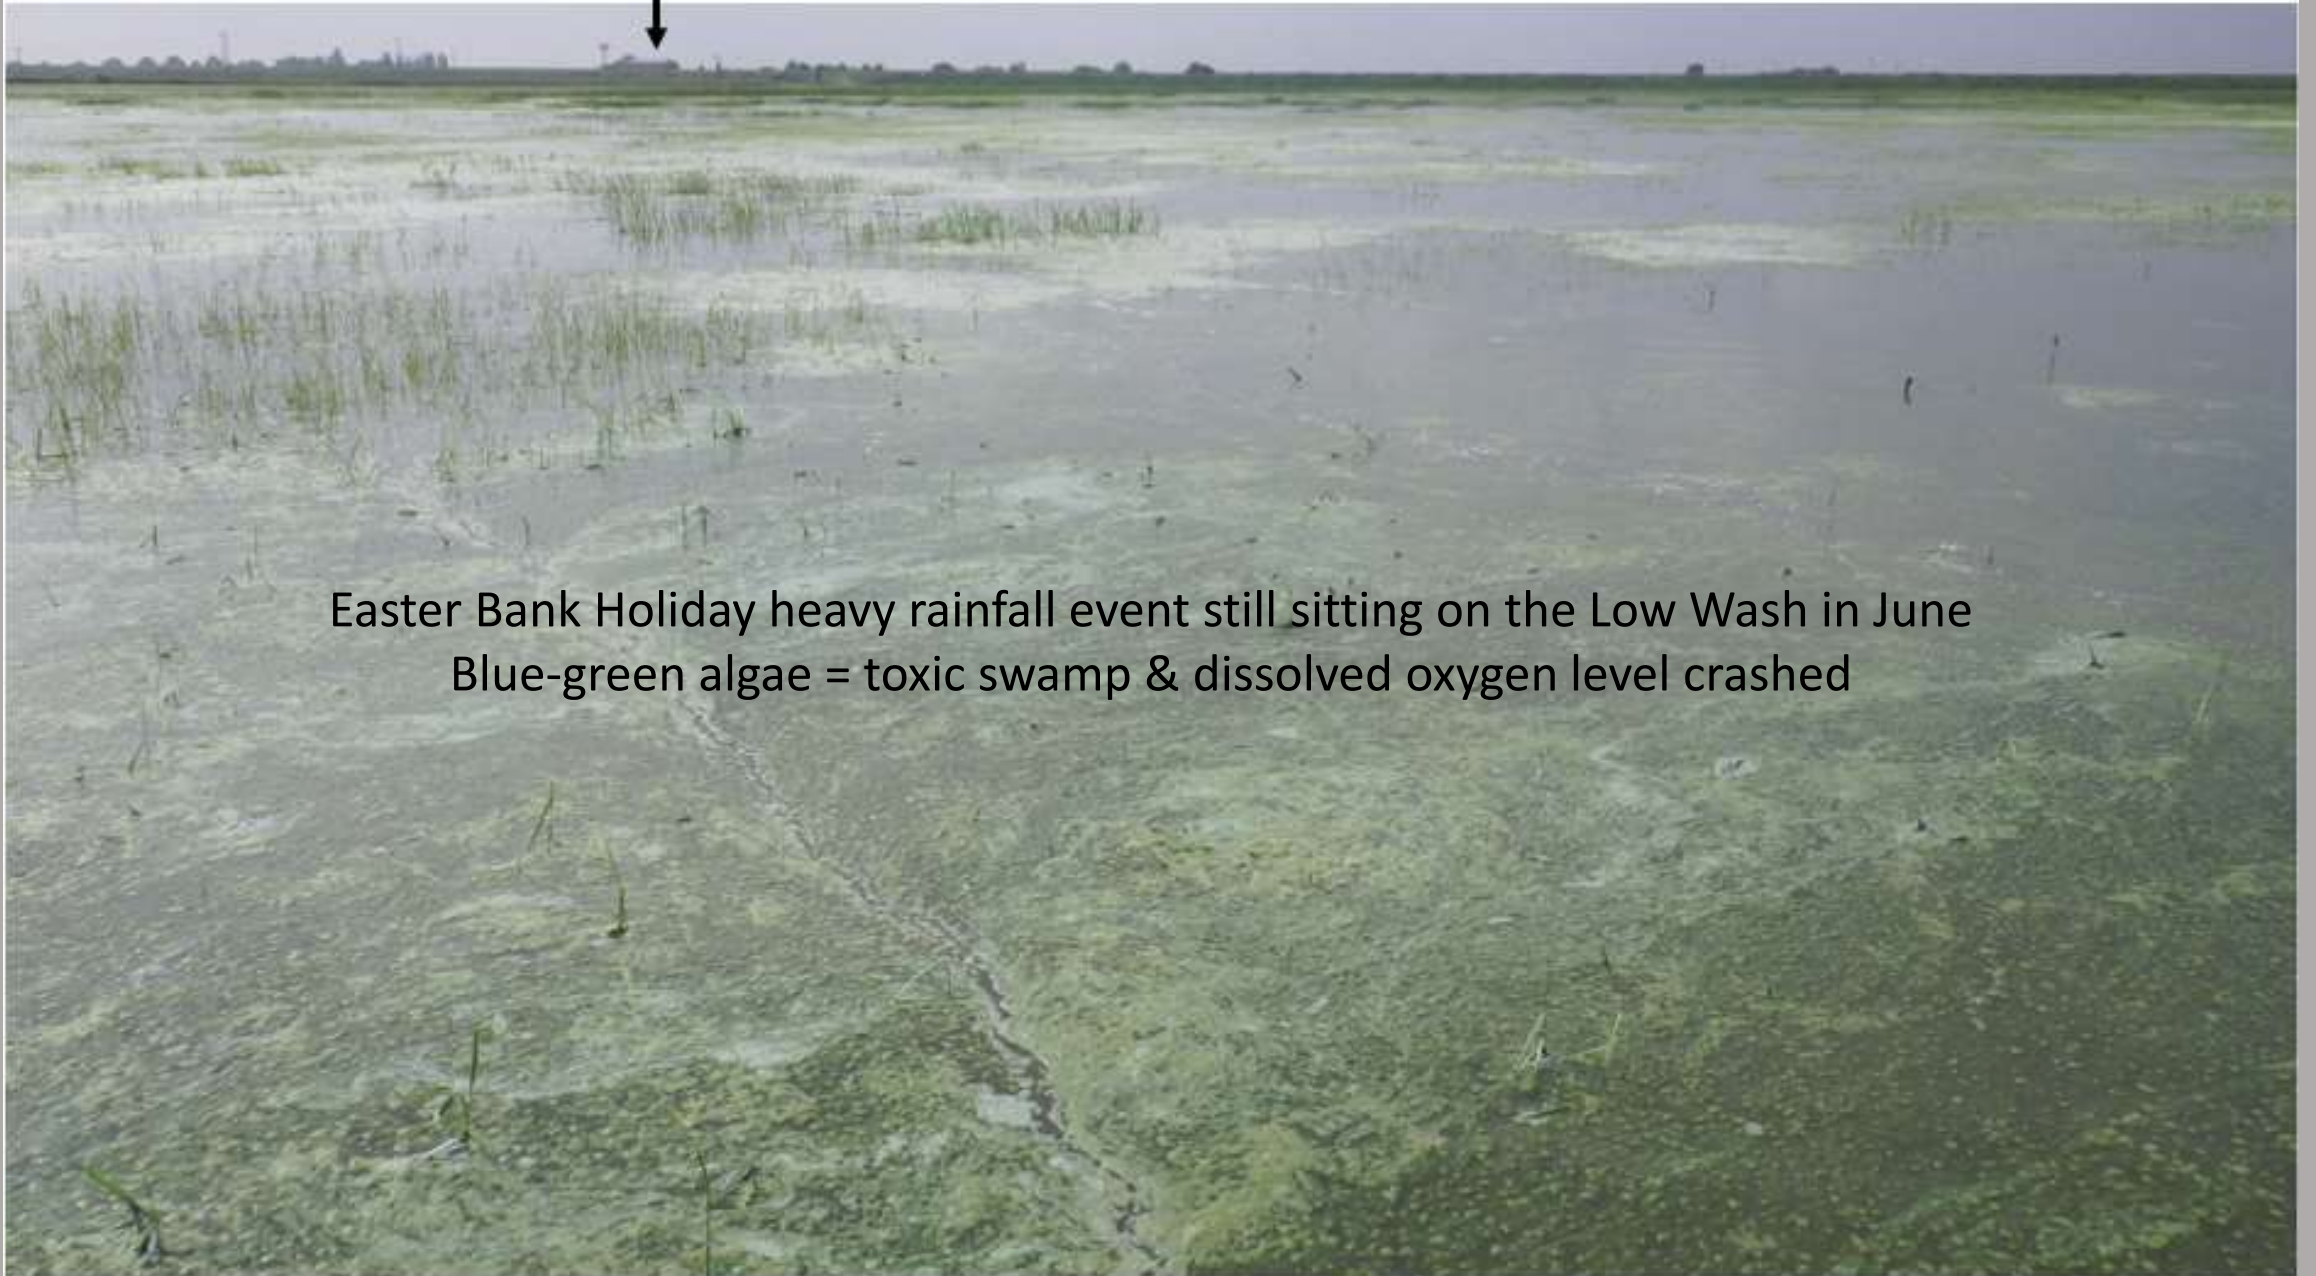
Nene Washes @ March Farmers 535235/300967 04/06/2018

Easter Bank Holiday heavy rainfall event still sitting on the Low Wash in June  
Blue-green algae = toxic swamp & dissolved oxygen level crashed

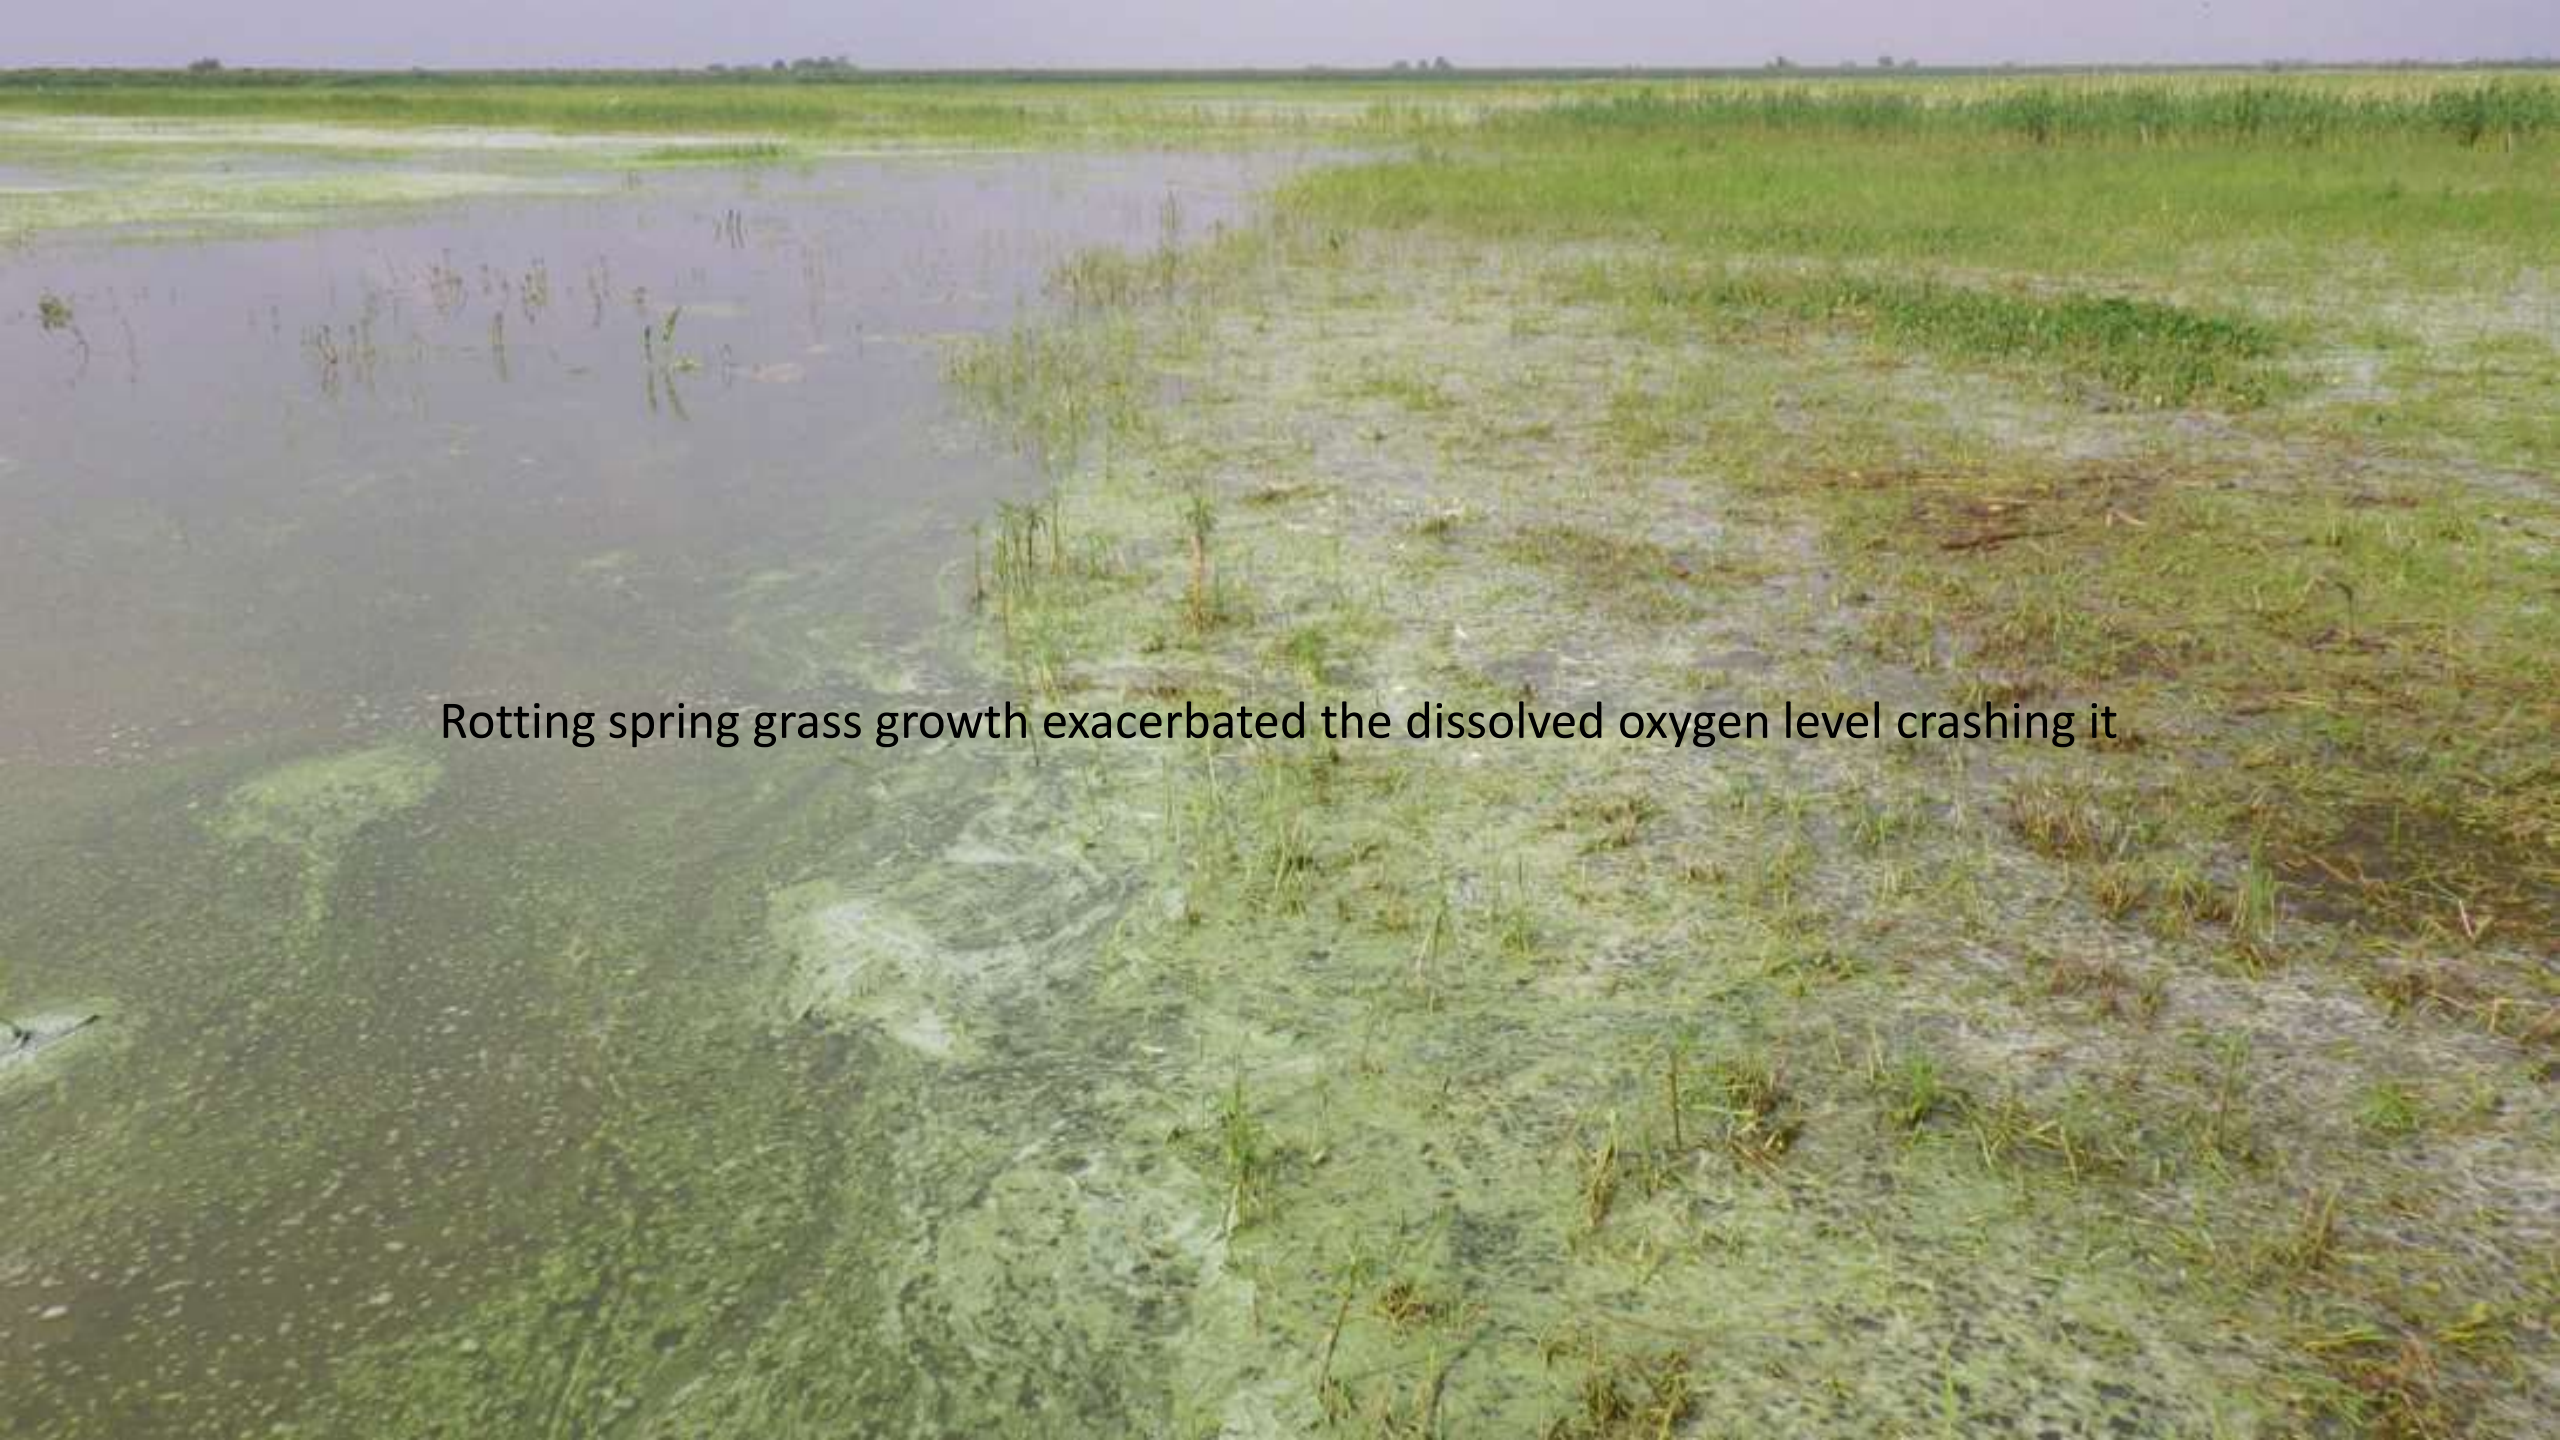
Rotting spring grass growth exacerbated the dissolved oxygen level crashing it

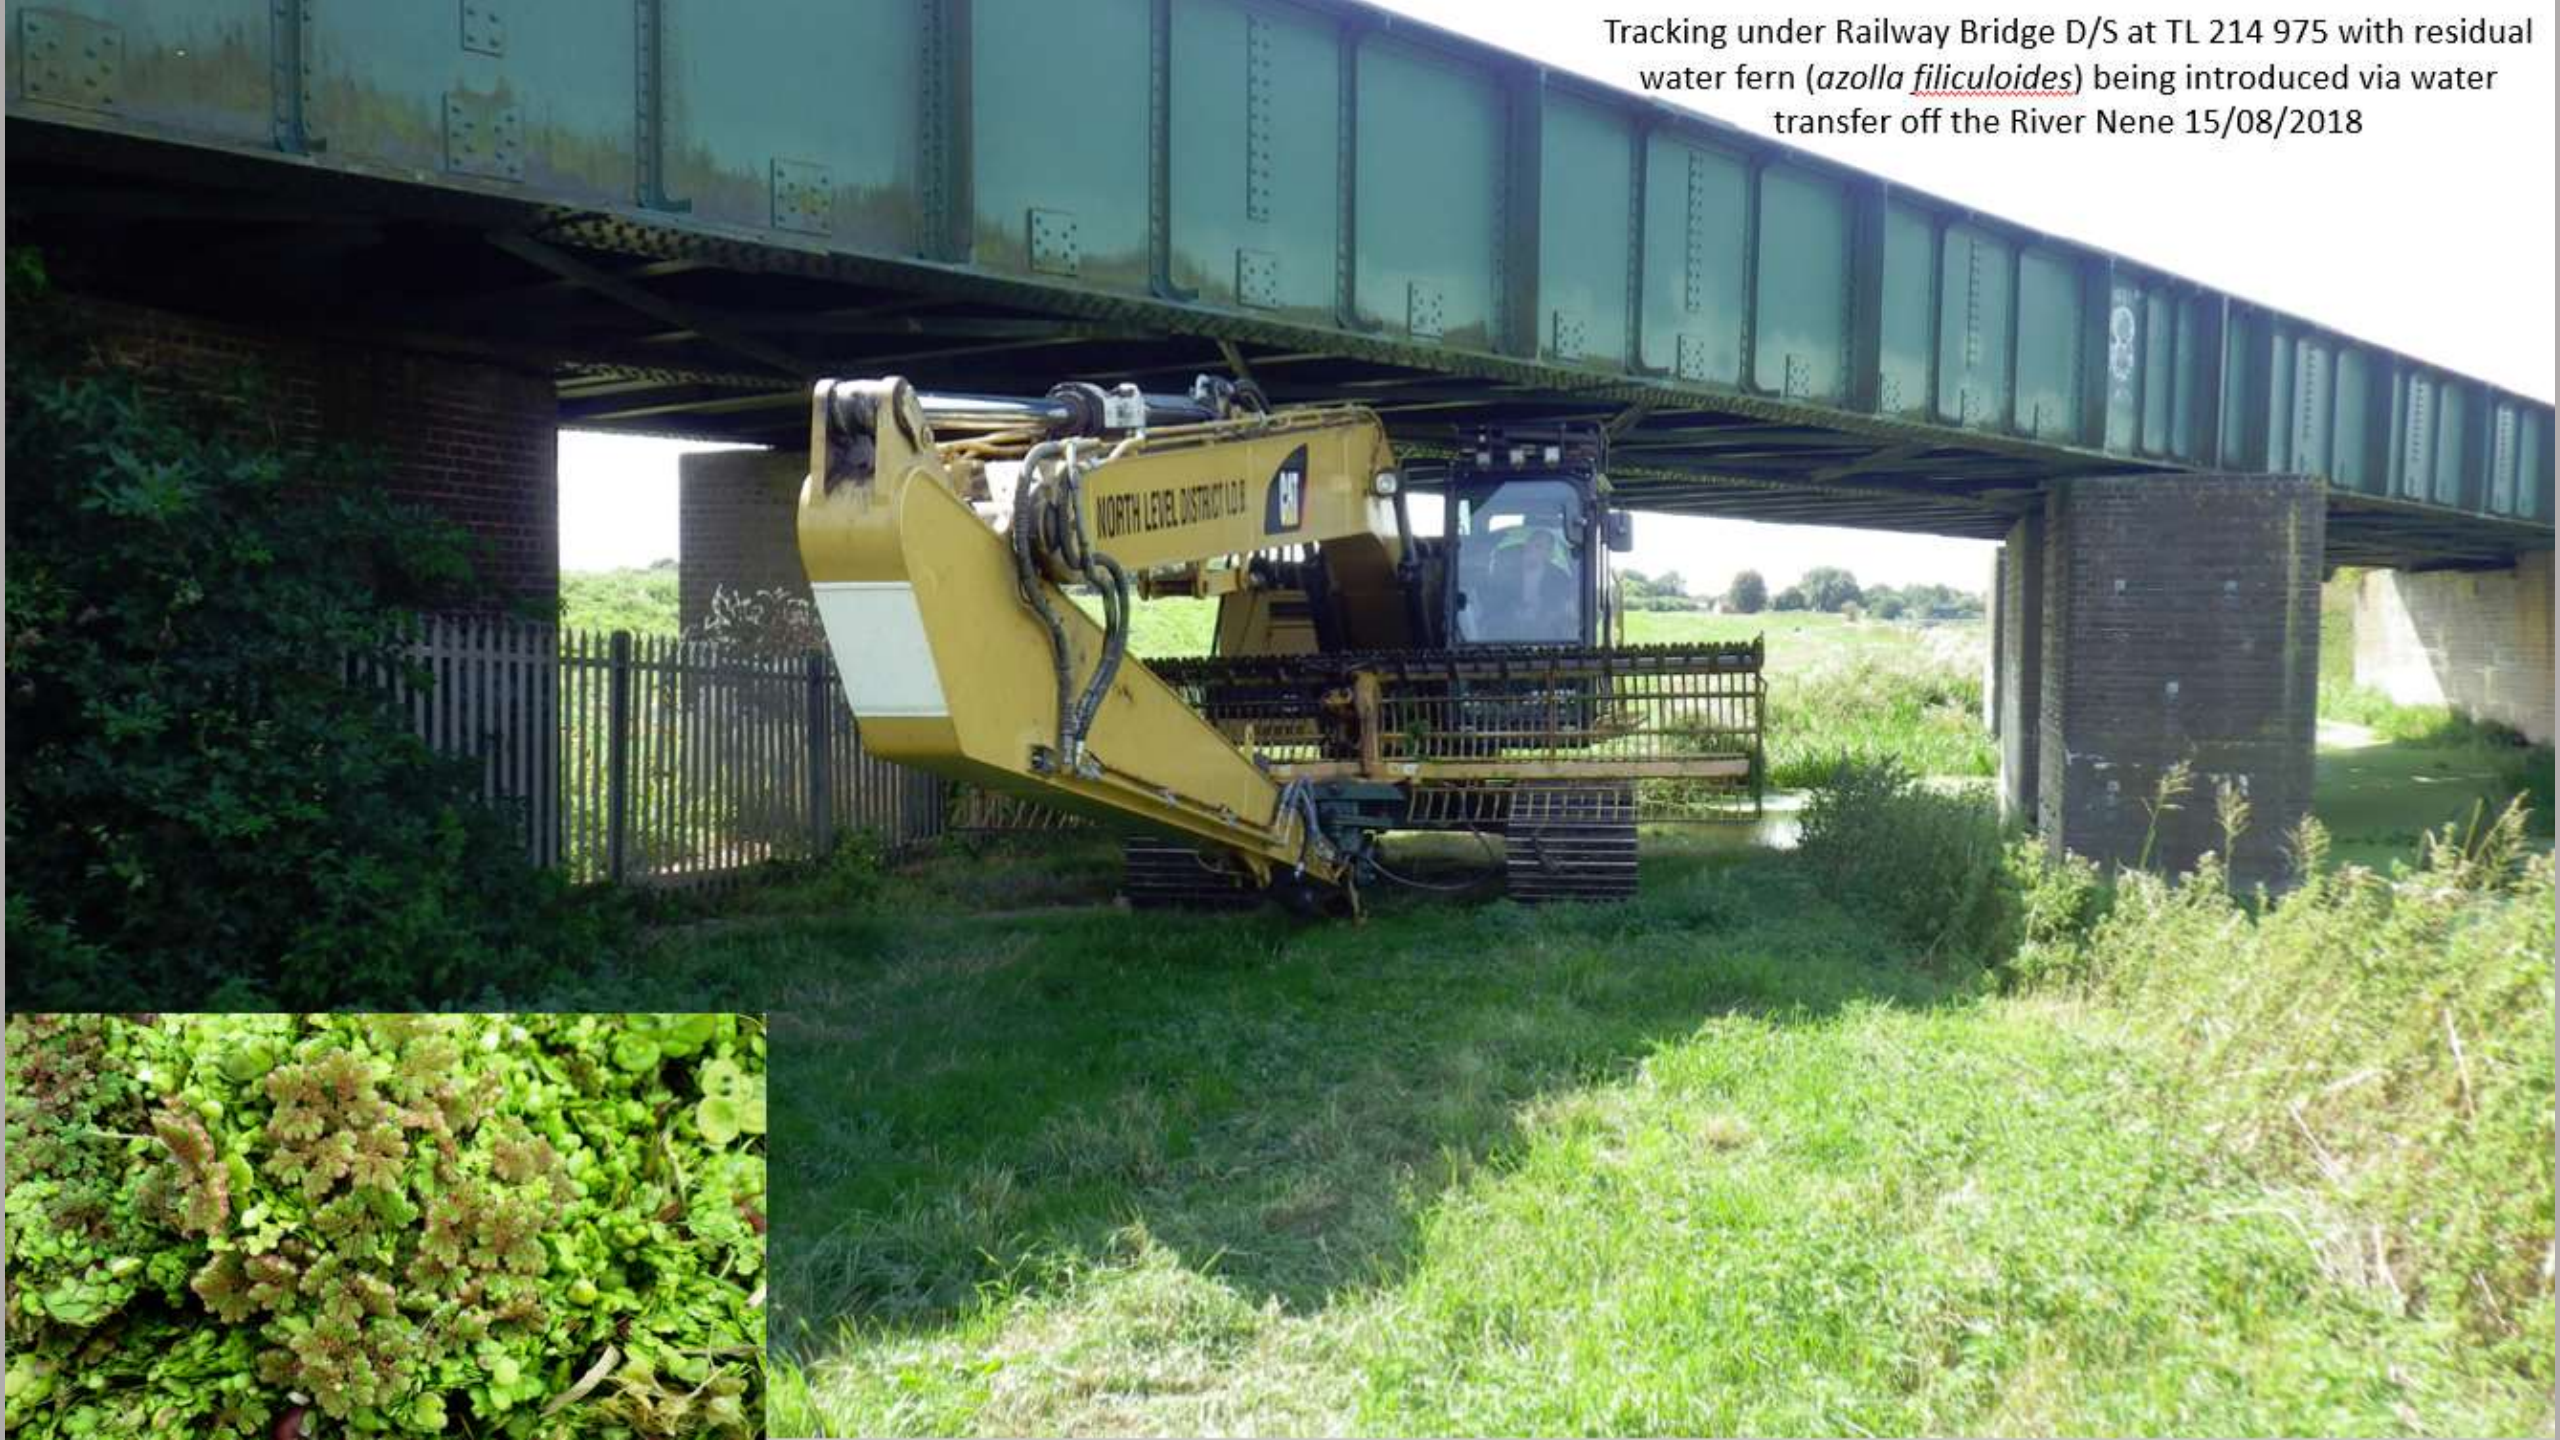
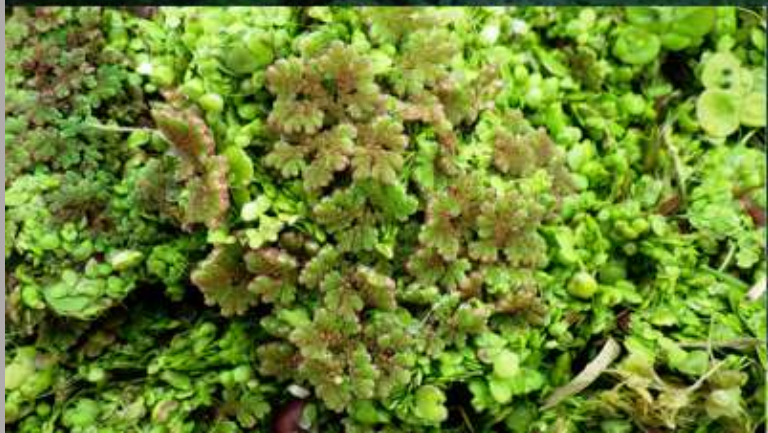
Tracking under Railway Bridge D/S at TL 214 975 with residual water fern (*azolla filiculoides*) being introduced via water transfer off the River Nene 15/08/2018

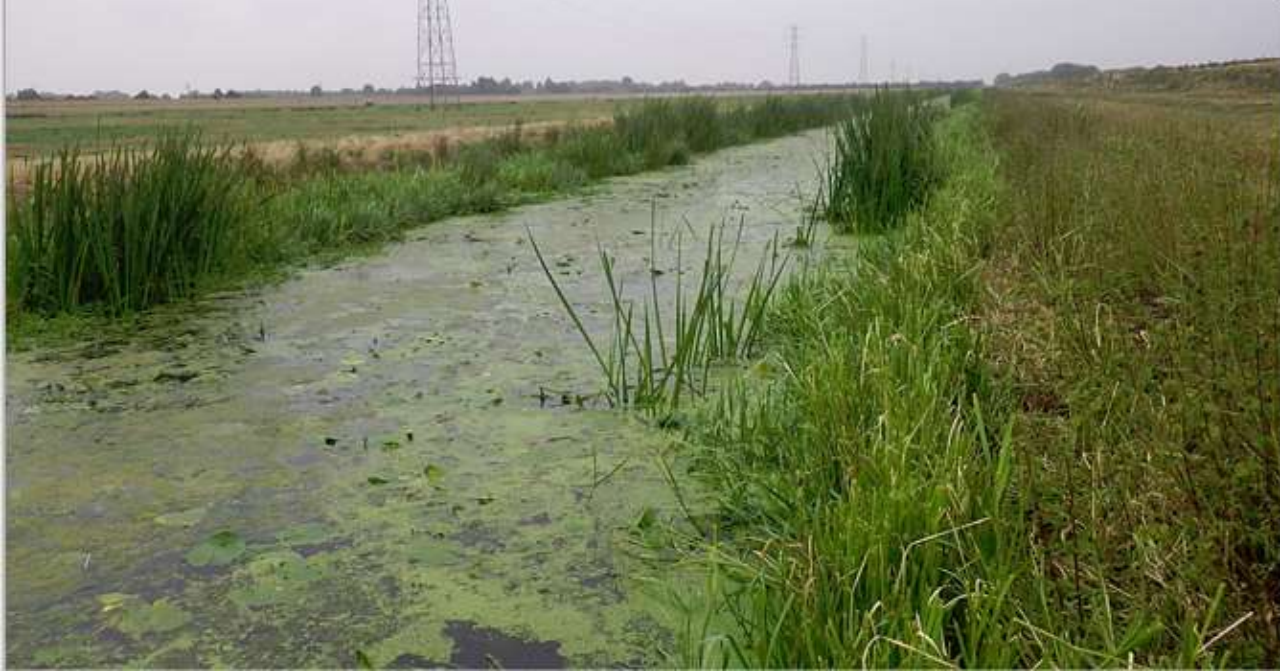
Macrophyte encroachment U/S Ball Bridge TL 224/978 9/8/18

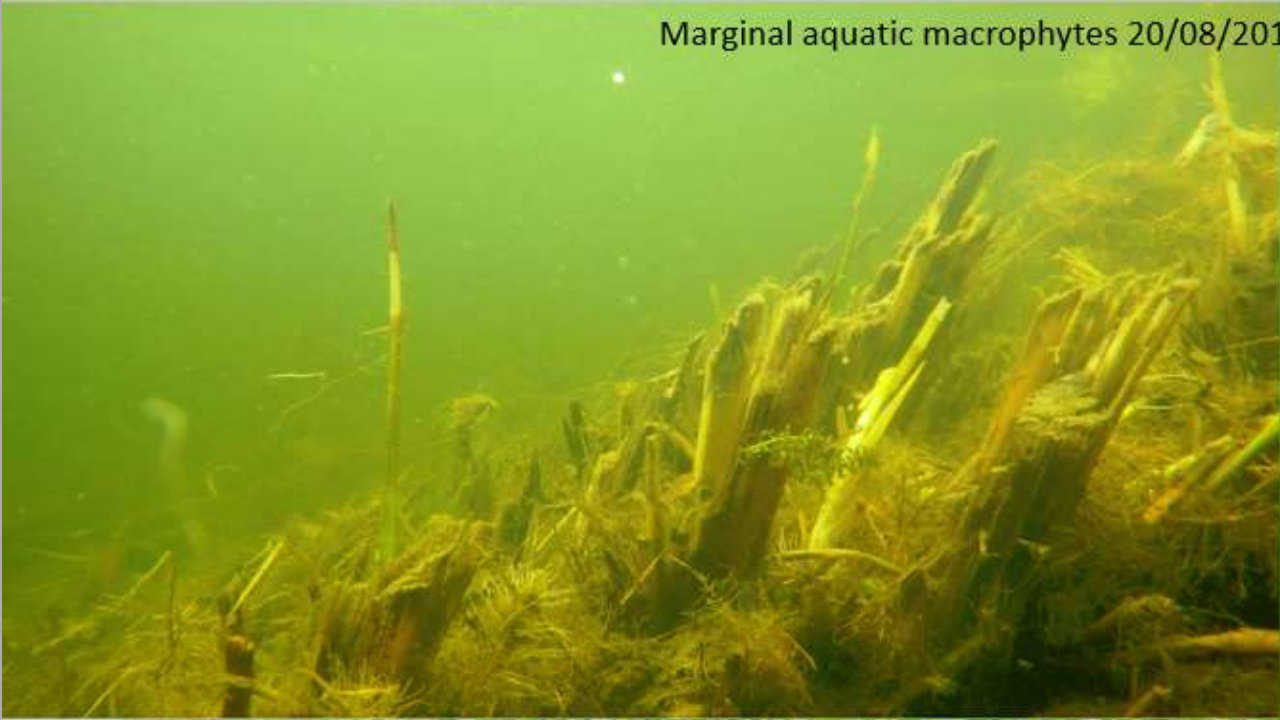
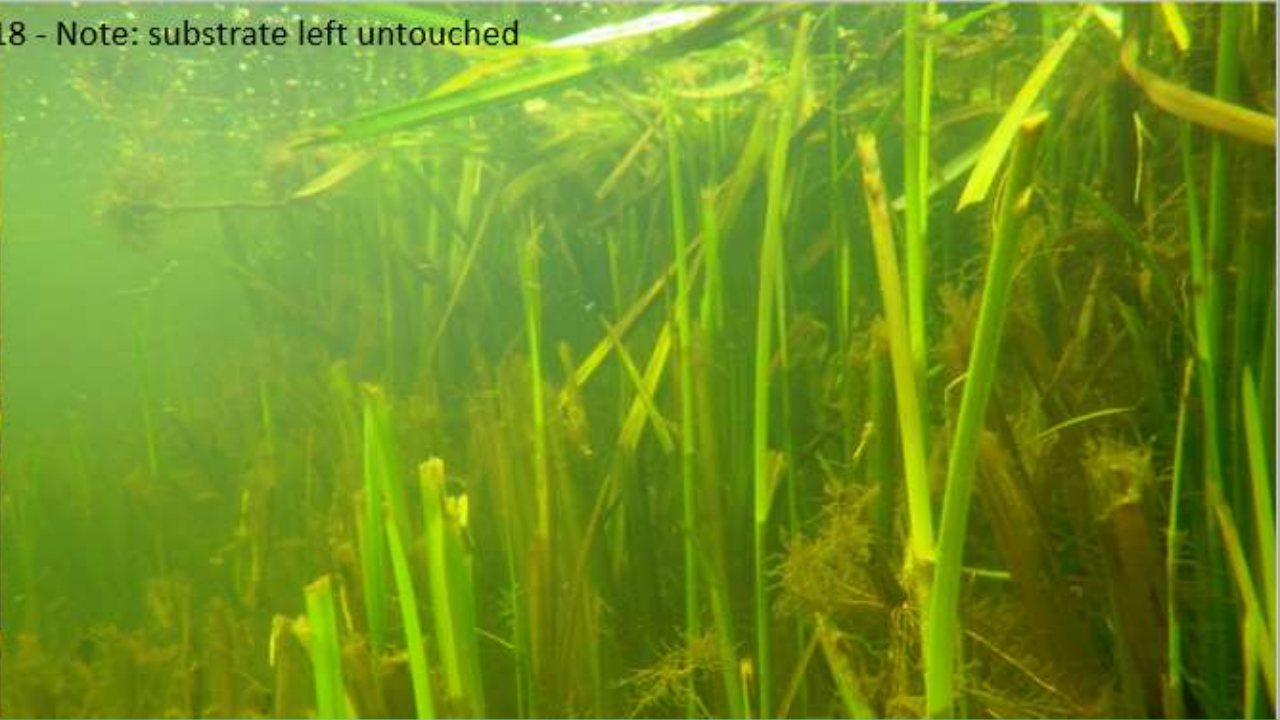
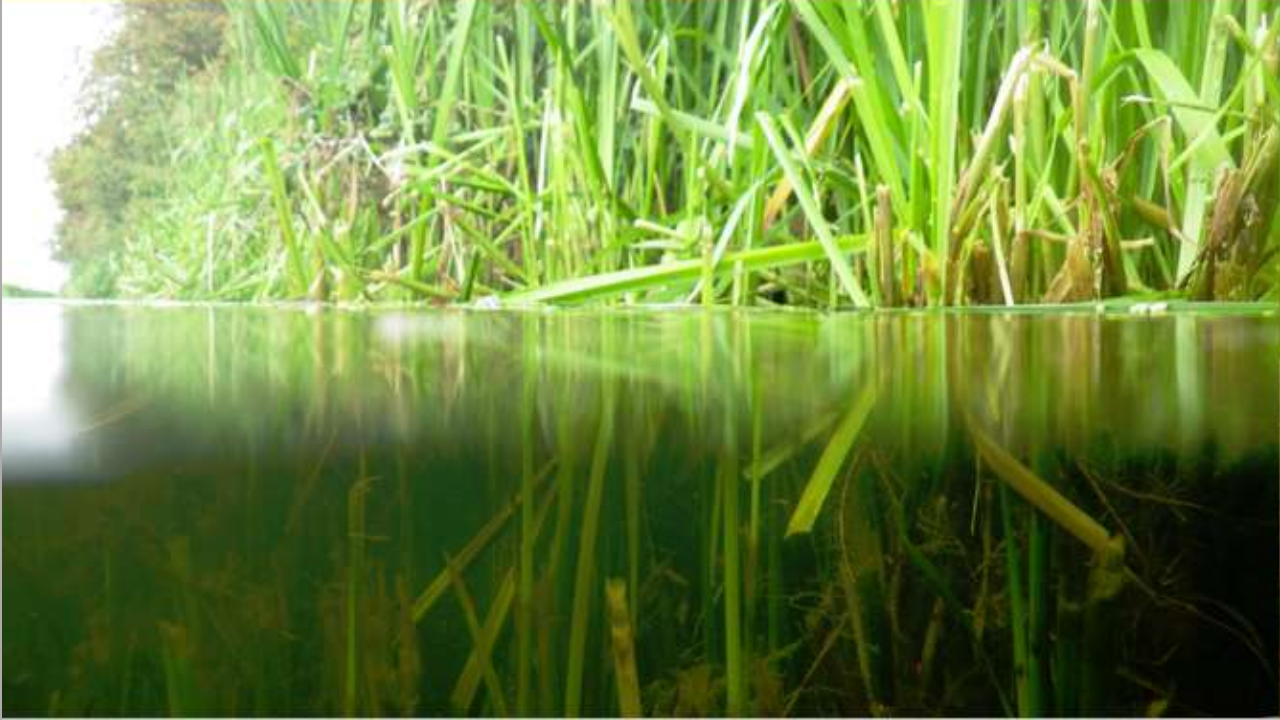
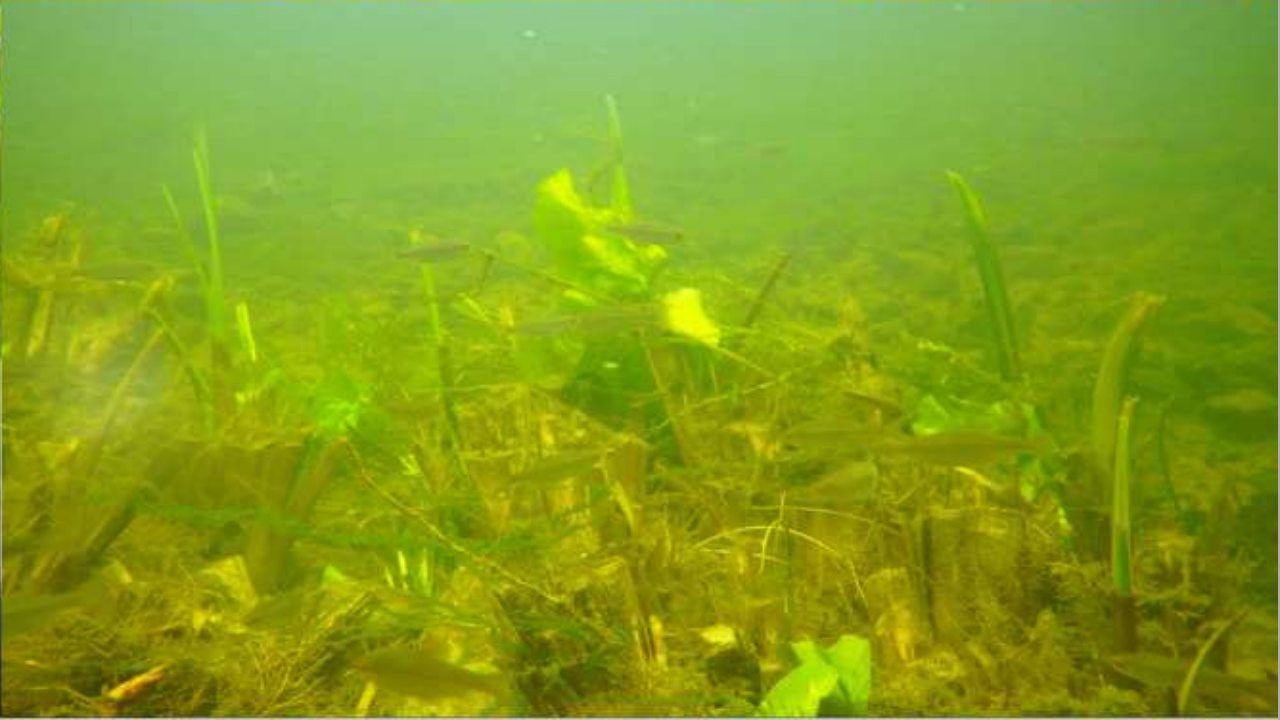
Marginal aquatic macrophytes 20/08/2018 - Note: substrate left untouched

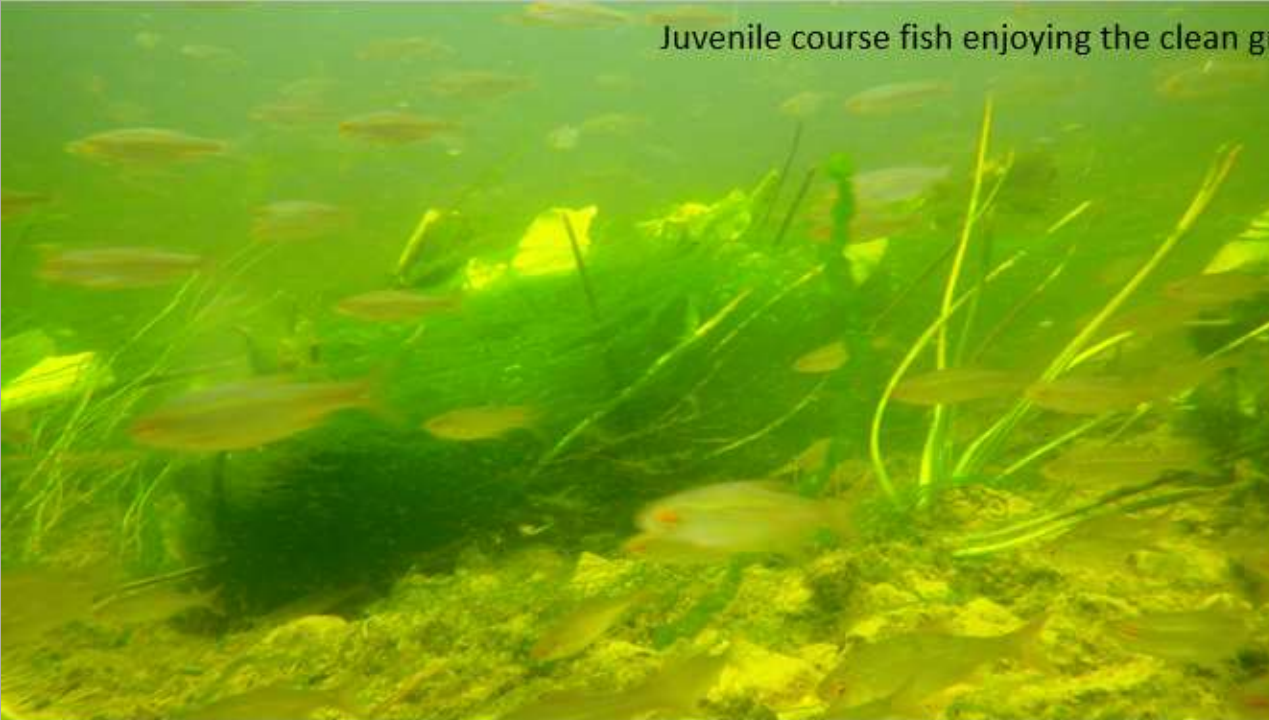
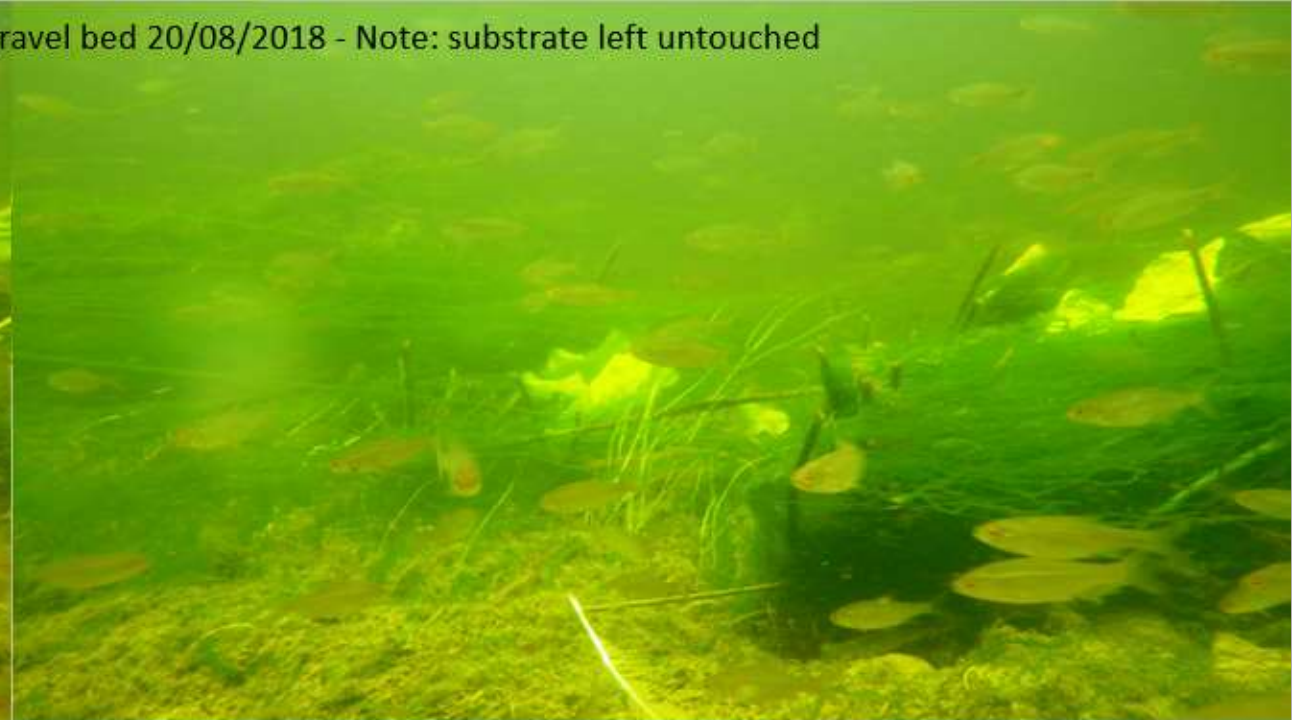
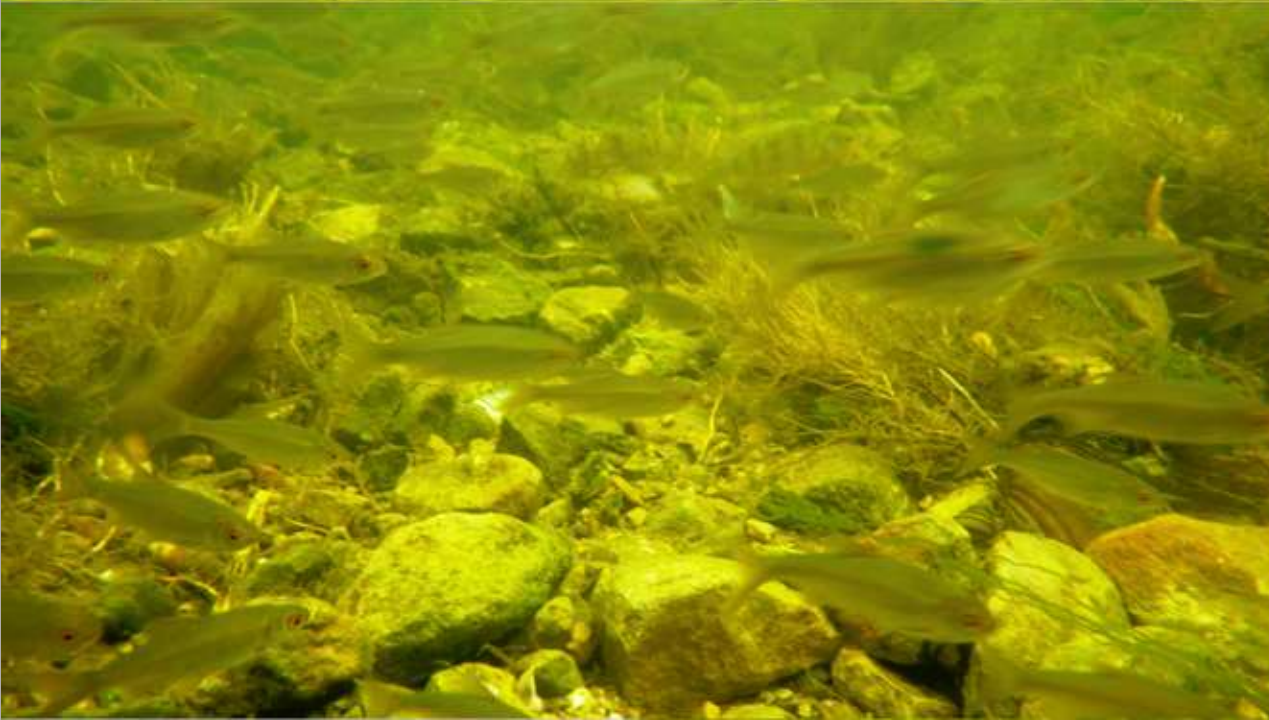
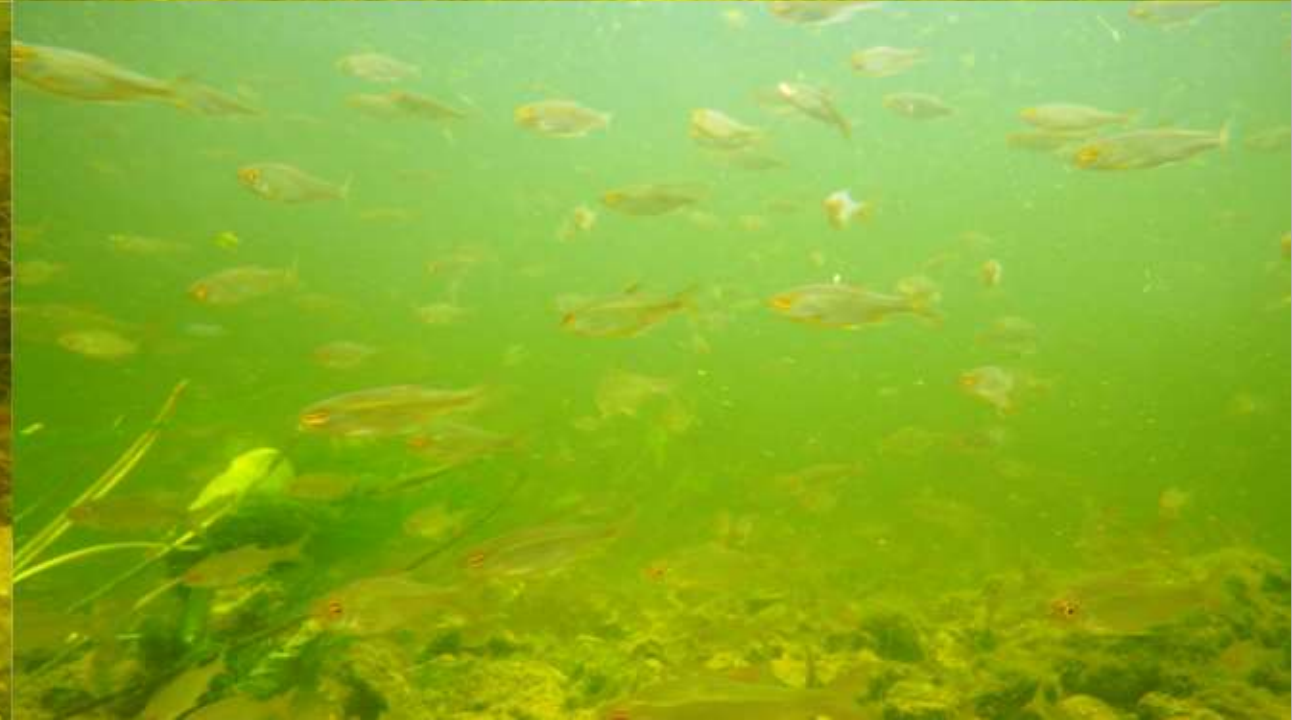
Juvenile course fish enjoying the clean gravel bed 20/08/2018 - Note: substrate left untouched

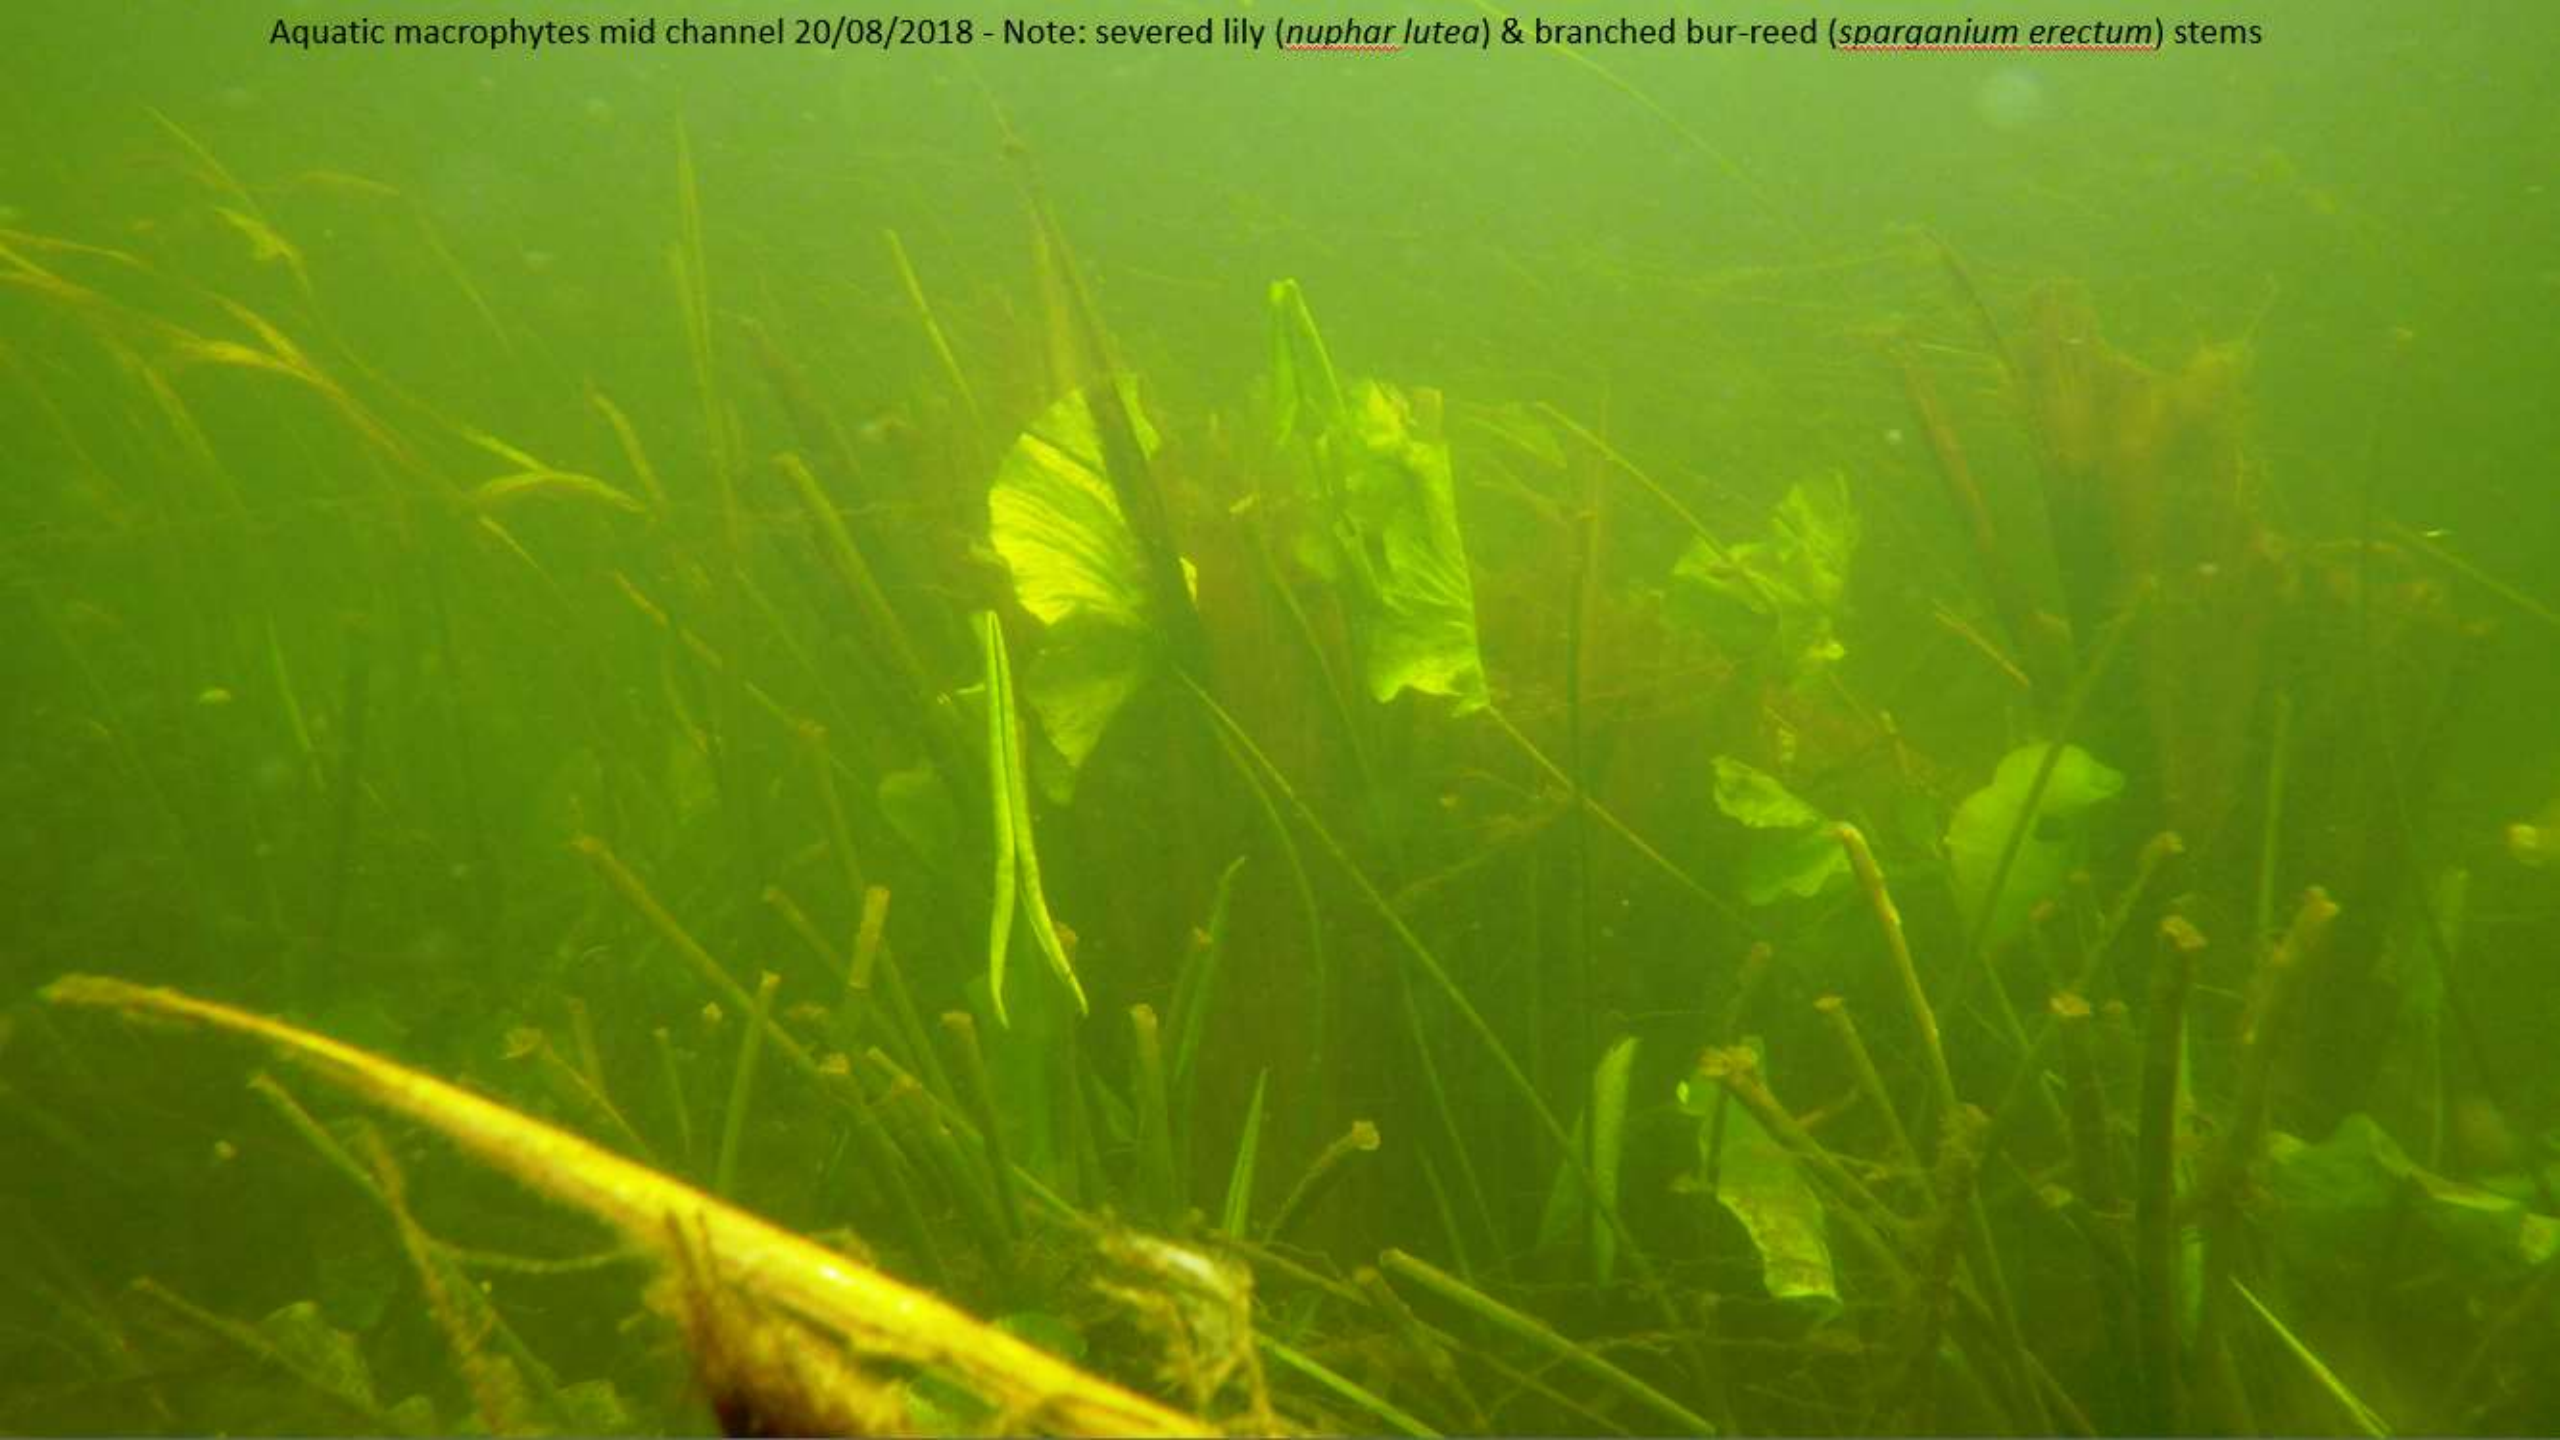
Aquatic macrophytes mid channel 20/08/2018 - Note: severed lily (*nuphar lutea*) & branched bur-reed (*sparaganium erectum*) stems
