# North Level District IDB: Nene Washes Morton's Leam Aquatic Weed Control, August 2018

Martin Redding, Project Engineer, North Level IDB 15/03/2019

# North Level District IDB: Morton's Leam Aquatic Weed Control between Stanground Sluice & Little Bridge August 15-17<sup>th</sup> 2018

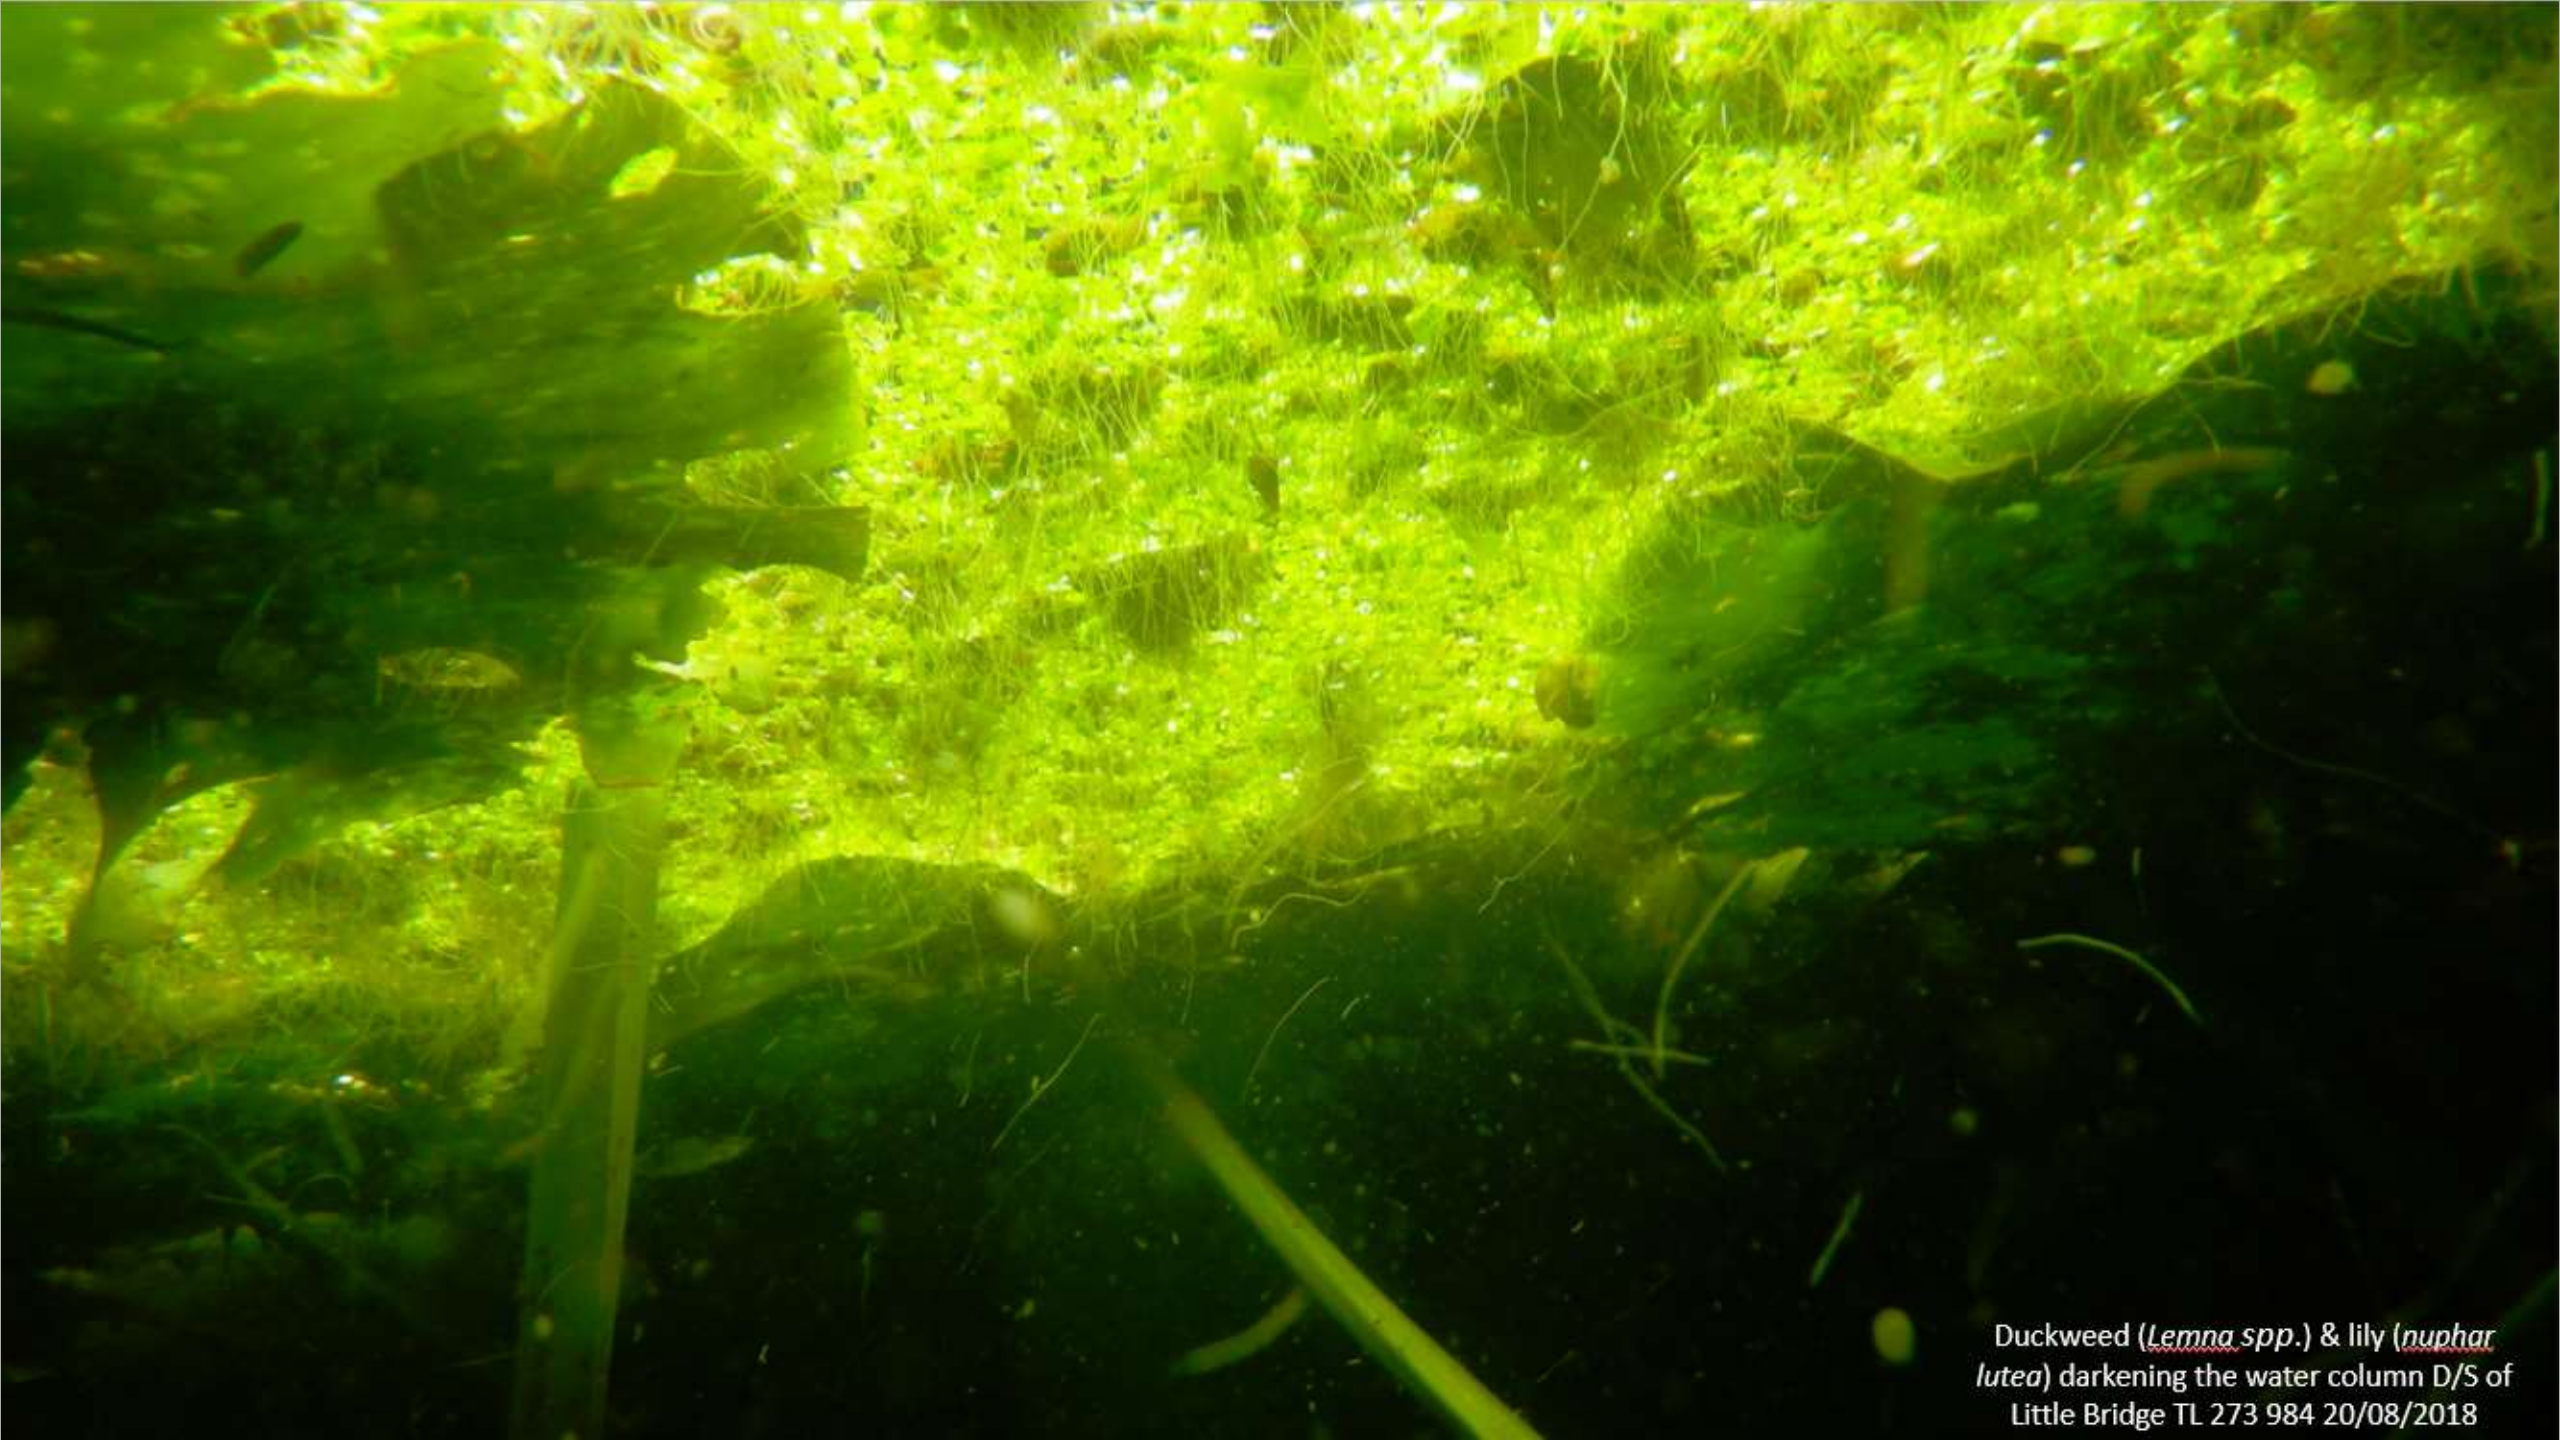
Duckweed (*Lemna spp.*) & lily (*nuphar lutea*) darkening the water column D/S of Little Bridge TL 273 984 20/08/2018
