**Floating Pennywort, *Hydrocotyle ranunculoides* eradication programme
on Exminster Marshes, nr Exeter, Devon**

2000 – 2013

Kevin Ackerman¹, Lesley Kerry² and Mike Williams³

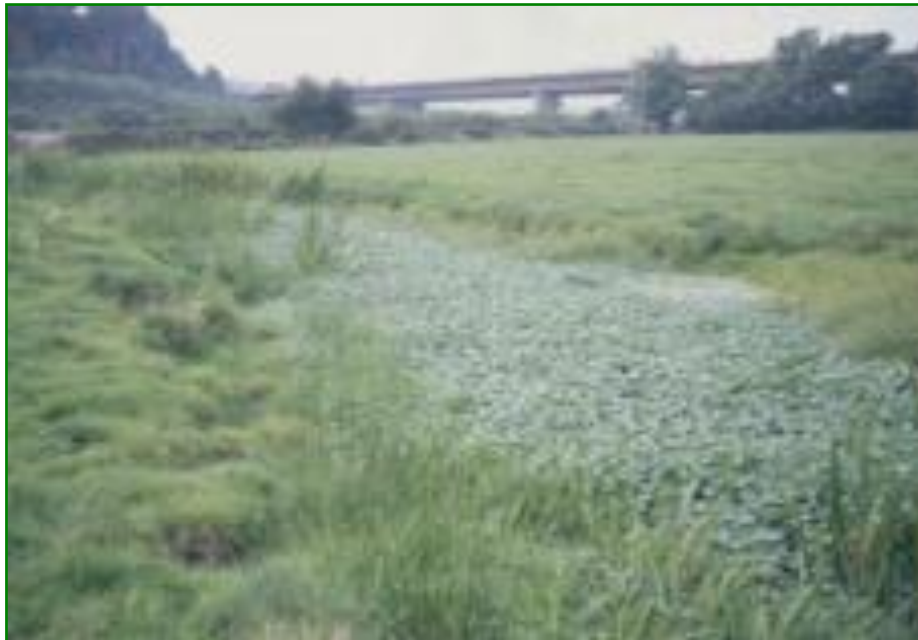
1. Ditch choked with Floating pennywort, with M5 bridge in background 1999

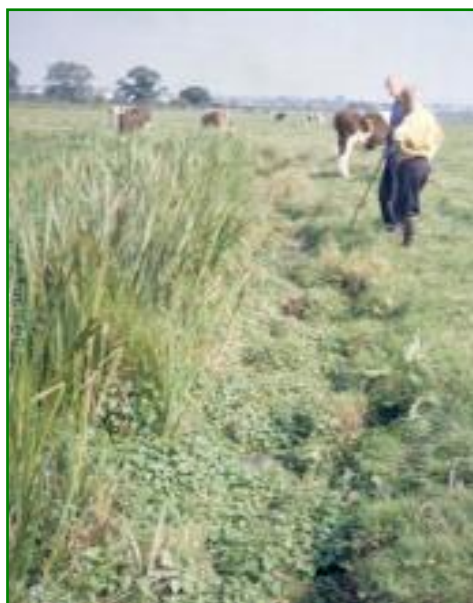
2. Ditch choked with Floating pennywort

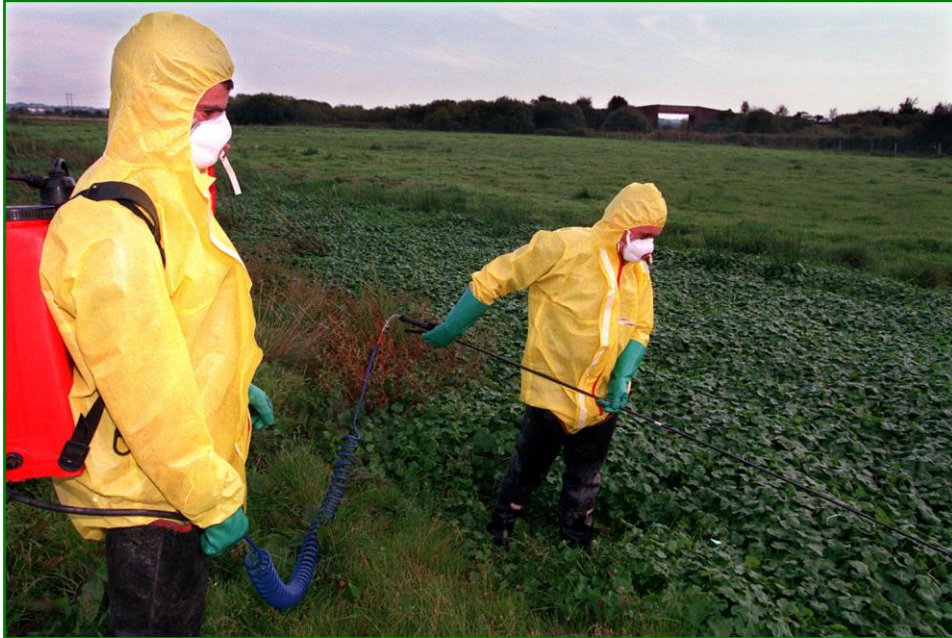
3. Spraying with Reglone

After Floating pennywort was discovered in September 1999 it was felt that mechanical control would be too disruptive and damaging for the ditch flora and fauna so while the problem was still confined to 6 ditches EA sprayed Diquat as Reglone. Although this was initially effective the plant soon recovered and continued to spread.

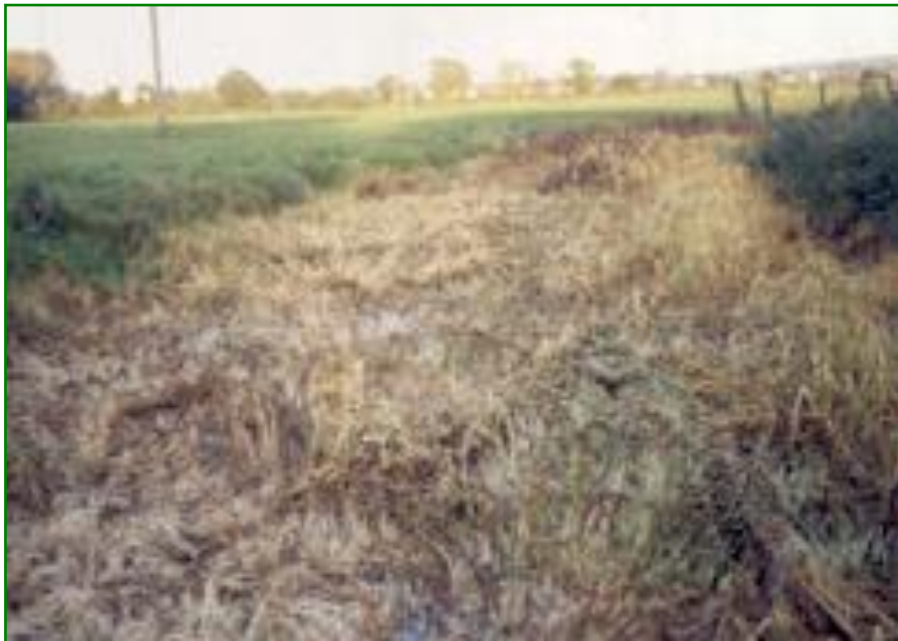
4. Ditch with sprayed Floating pennywort

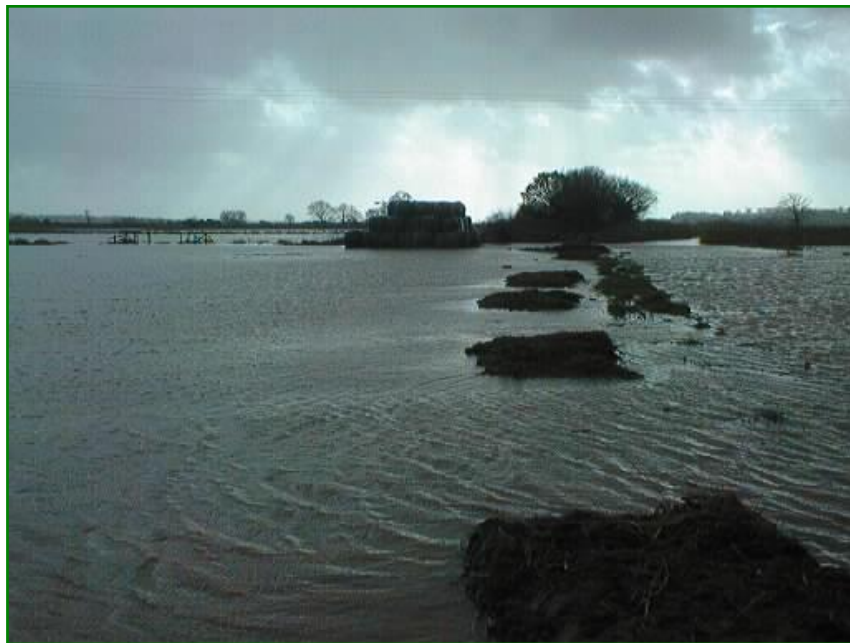
5. Flooding spreading fragments of Floating pennywort downstream

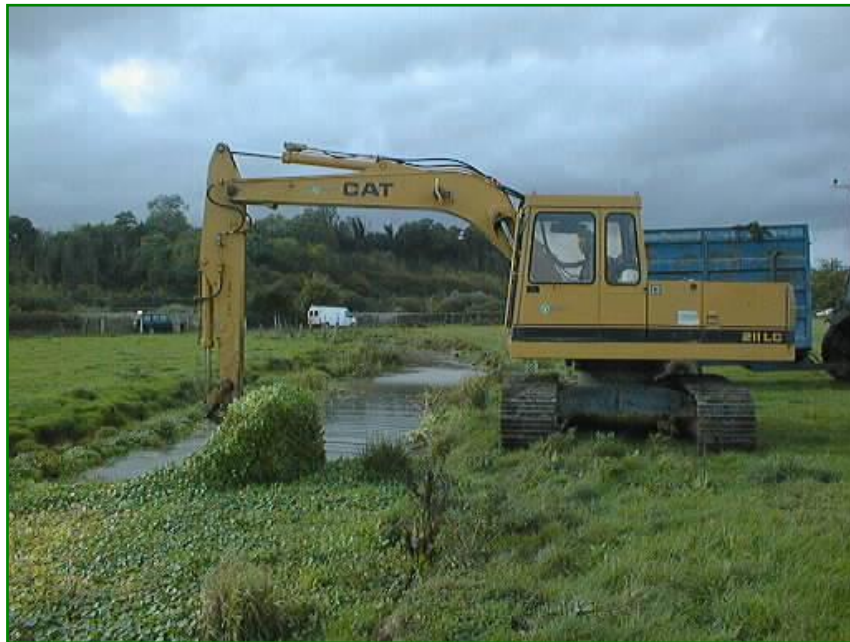
6. Removal of floating mat

In 2002 the removal programme was re-started with the floating carpets dredged by diggers, loaded into silage trailers, allowed to drain and then removed to a compost site.

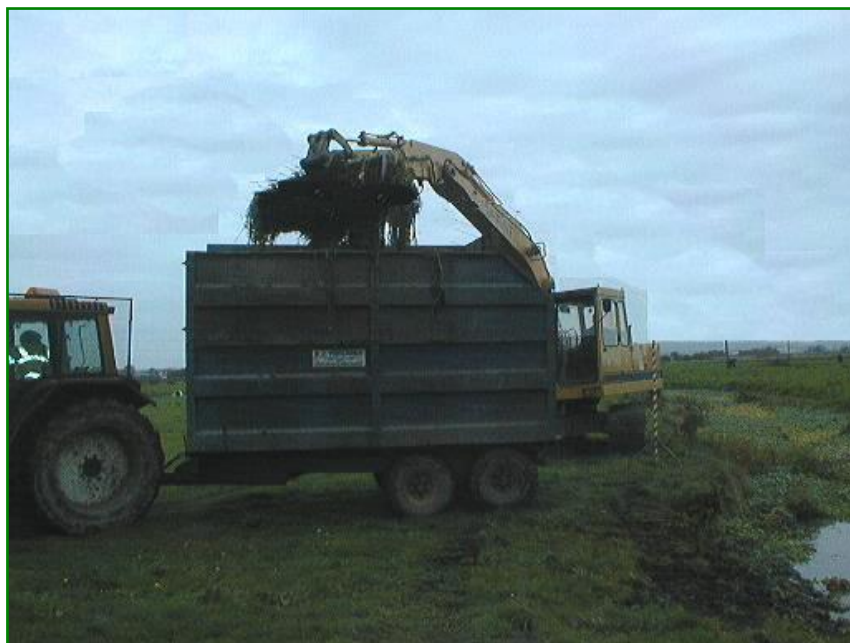
7. Loading into silage trailers prior to removal to compost site

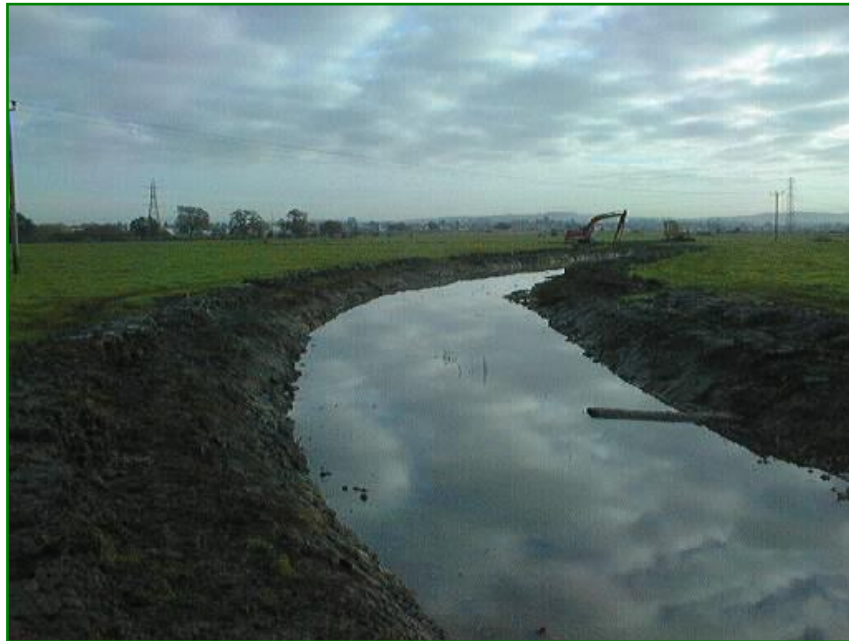
8. Digger removing marginal plants and widening ditch

The next stage was to remove the marginal plants which were rooted into the bank. These dredgings contained too much silt to be accepted for composting and it was too expensive to take to landfill (£30 per linear metre), therefore the plants were buried on site. The dredging resulted in widening of the ditches. Whilst dredging had an initial impact in removing the main mass of the weed many roots and fragments were left behind and these regrew.

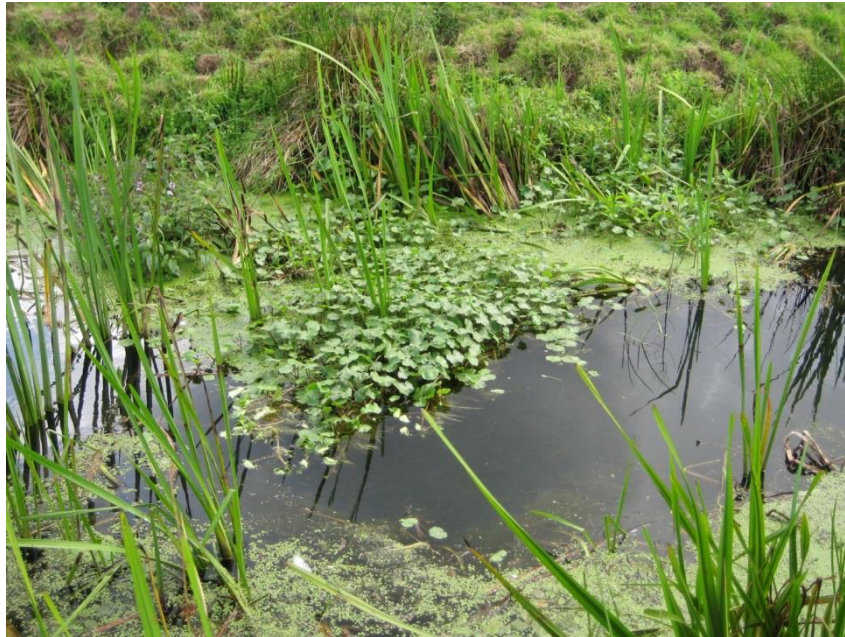
It appeared that Floating pennywort starts growing in May with an increase in leaf size and the plant starts to grow across the ditches. After the first one or two removals the plant abundance decreases in June and July before another growth spurt in August/September, as shown in Graph 1.

9. Plants starting to grow across a ditch in late May

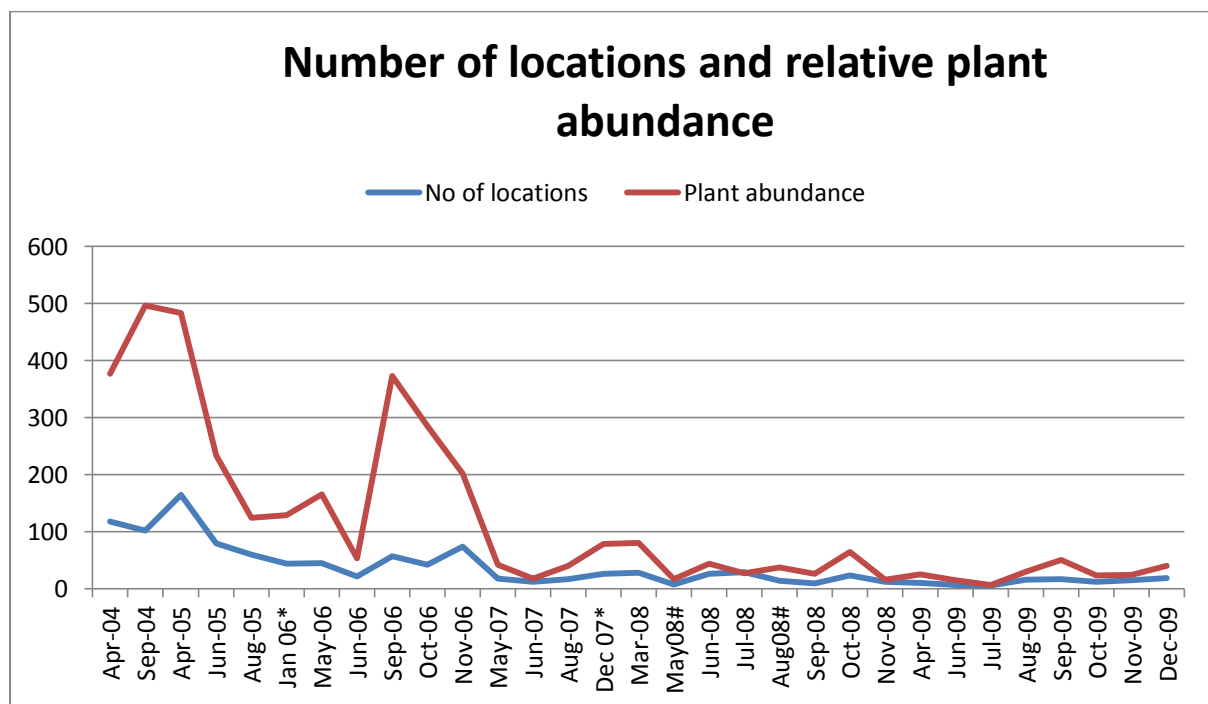
Graph 1

Date of survey	No of locations	Plant abundance	Date of survey	No of locations	Plant abundance	Date of survey	No of locations	Plant abundance
Apr-04	118	377	Mar-08	28	80	Apr-10	0	0
Sep-04	102	496	May08#	7	17	May-10	0	0
Apr-05	164	483	Jun-08	26	44	Jun-10	0	0
Jun-05	79	234	Jul-08	29	27	Jul-10	0	0
Aug-05	60	124	Aug08#	14	37	Aug-10	0	0
Jan 06*	44	129	Sep-08	9	26	Sep-10	0	0
May-06	45	165	Oct-08	23	64	Oct-10	0	0
Jun-06	21	53	Nov-08	12	16	Nov-10	0	0
Sep-06	57	373	Apr-09	10	25	May-11	0	0
Oct-06	42	285	Jun-09	6	15	Jul-11	0	0
Nov-06	74	202	Jul-09	5	6	Oct-11	0	0
May-07	18	42	Aug-09	16	30	May-12	0	0
Jun-07	12	18	Sep-09	17	50	Oct-12	0	0
Aug-07	17	40	Oct-09	12	23	Sep-13	0	0
Dec 07*	26	78	Nov-09	15	24			
			Dec-09	19	40

- Whole ditches recorded as being infested prior to 2004.
- Plant abundance is a subjective measure and only gives a relative indication of the decrease in biomass. The swamp area is not included here.
- * Partial surveys carried out only due to no access during winter months on RSPB land south of Station Road. This area is reserved for wintering wildfowl.
- # Partial surveys only as removal being carried out at the same time.

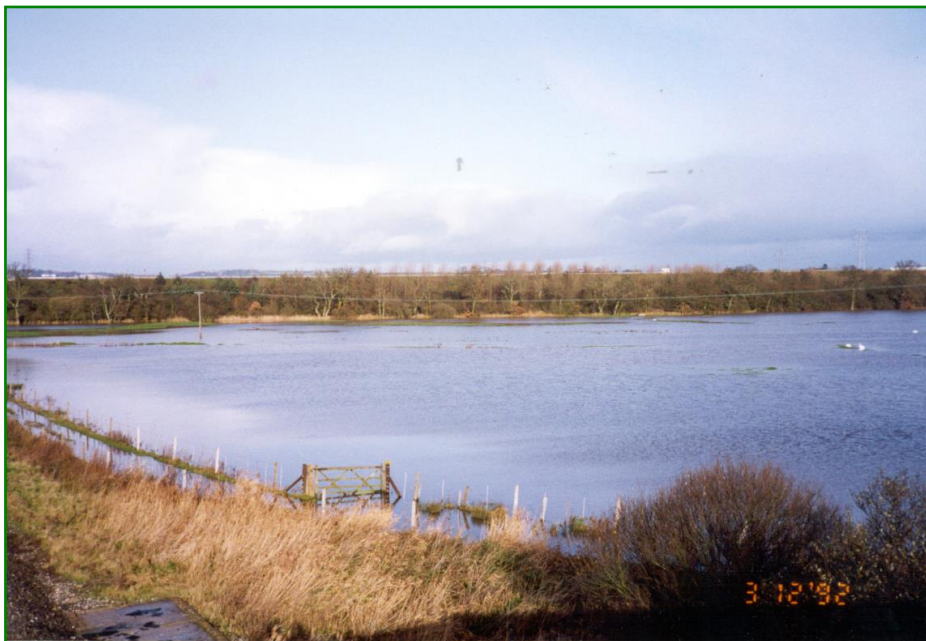
Again winter flooding probably spread fragments around the system, with Floating pennywort appearing in new places downstream in the summer after flooding. These isolated patches were soon removed.

10. Winter flood

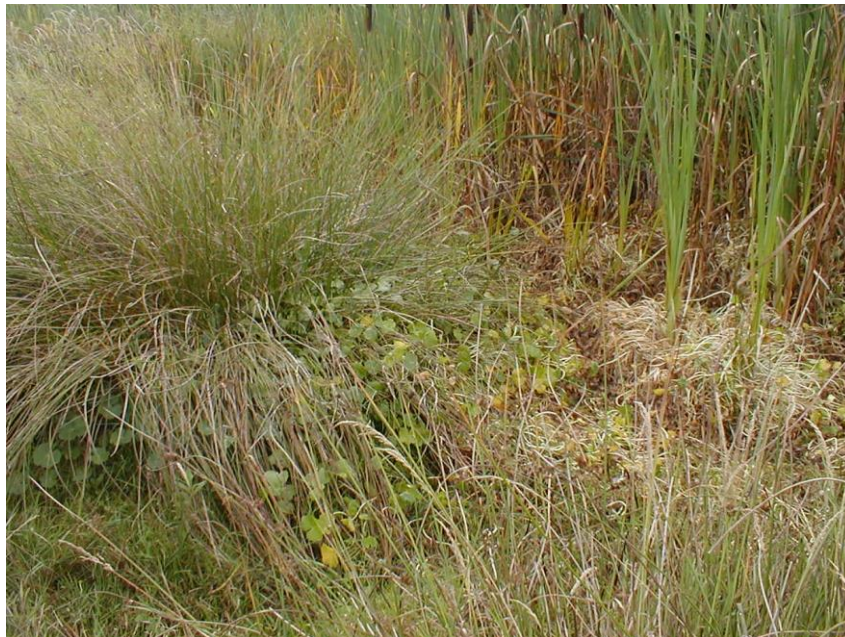
The density of the *Typha* and reed stems made access to the area difficult and it was impossible to hand-pull the Floating pennywort stems as they often broke off leaving root fragments behind. It was then difficult to dig these out due to the mat of other roots. Spot-spraying with 2-4D Amine during 2005 had some effect in reducing the amount of Floating pennywort present but it soon regrew.

11. Swamp area after spraying 2005 showing sprayed and unsprayed plants

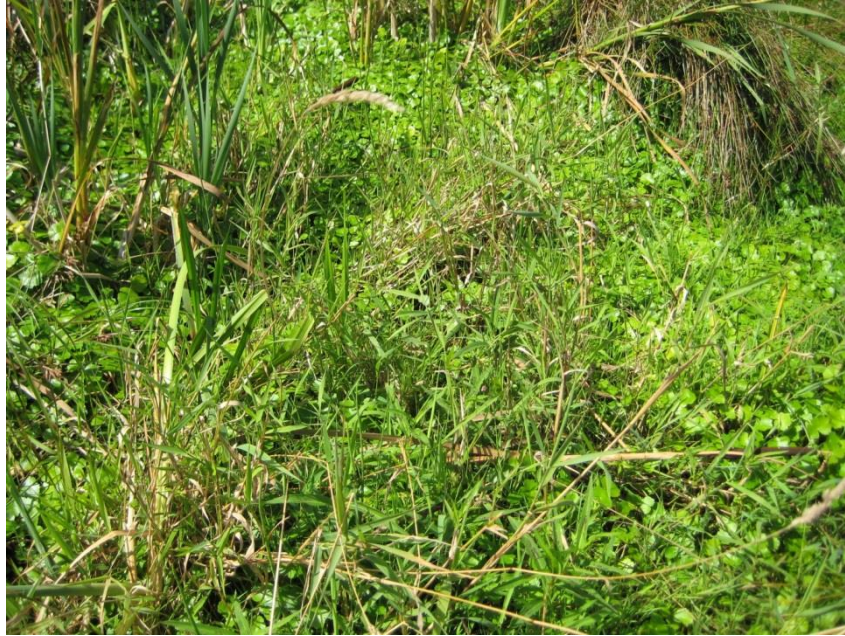
12. Plants in the swamp area before spraying in September 2007

In September 2007 transects were walked over the whole of the low-lying field and Floating pennywort was only found in the swamp area. This was sprayed with 2-4D Amine with the addition of 'Top Film' adjuvant. The untreated, clearly marked walkways through the stand were sprayed a week later, giving a total treatment with no overspray, which effectively reduced the biomass present. Only a few small plants with small leaves were located in December on the edges of the swamp area.

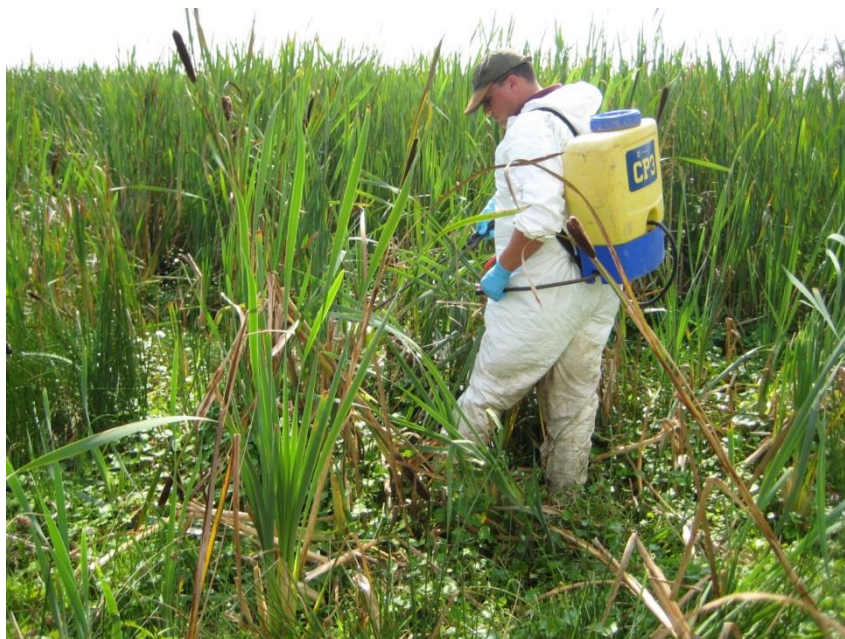
13. Spraying in the swamp area September 2007

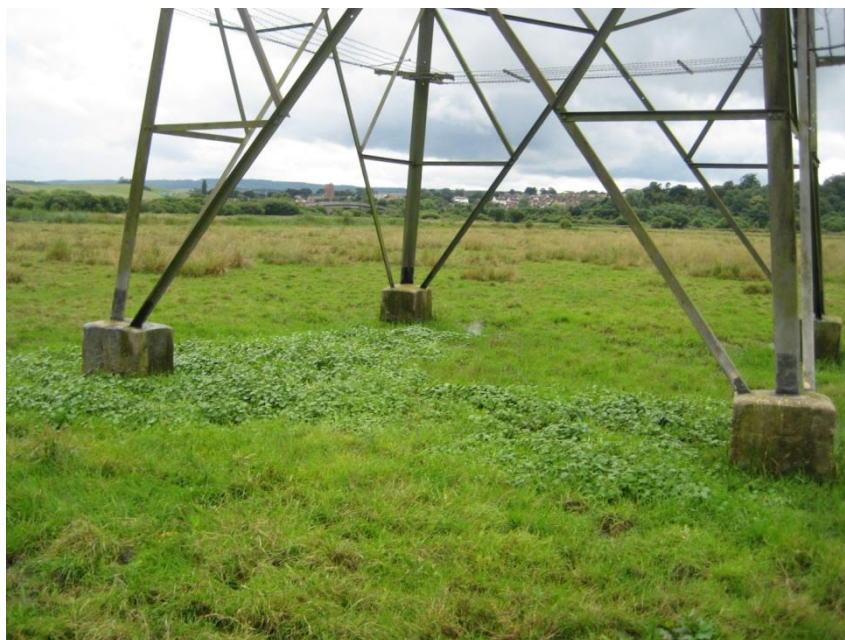
No Floating pennywort had been recorded here until July 2008, and spraying during September 2008 was followed up with root-digging. The last plants were dug out in December 2009 and none have been seen since. The area beneath the pylon is poached by cattle and often holds water during the winter months. It is some 3-5m from the nearest ditch and was dry throughout the growing period in 2010.

14. Plants under pylon July 2008

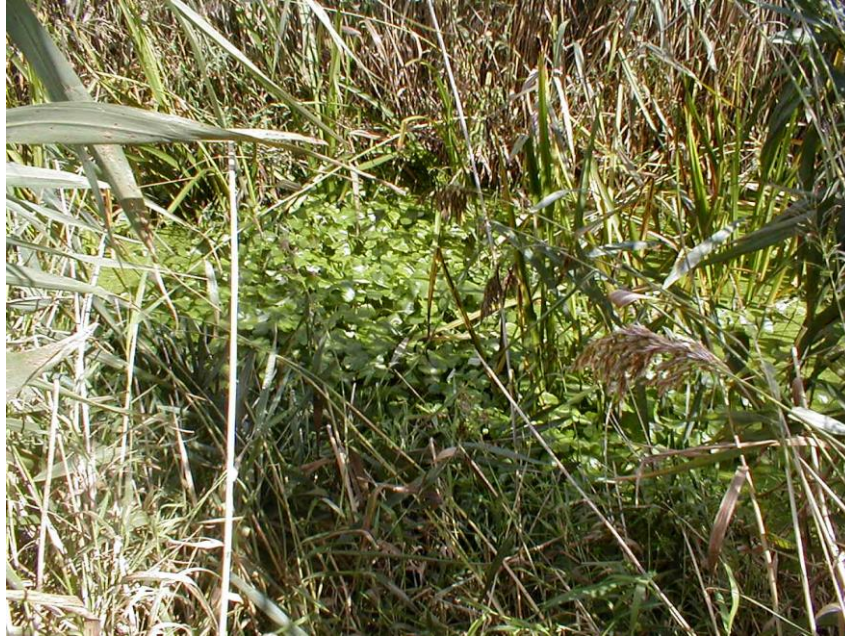
Black Gulf held persistent patches of Floating pennywort until 2010. It was a difficult ditch to survey and remove plants from due to the dense 2m tall fringe of reeds, which both obscured a view into the ditch from the bank and obstructed progress along the ditch in the water.

15. Plants in Black Gulf

Black Gulf ditch was dredged by Environment Agency in October 2009 and the surveyor was present to ensure the digger removed the Floating pennywort plants as cleanly as possible. The digger driver was very skilled but inevitably small fragments were left in the ditch. Follow-up visits by Kingcombe a week later and in December to remove both floating fragments and plants growing on the slubbings ensured no plants remained at the beginning of the winter.

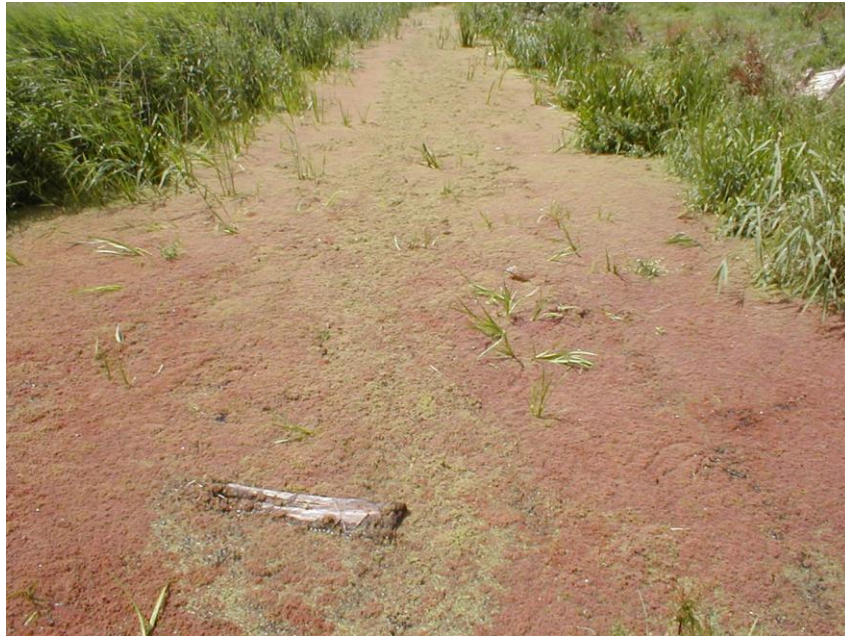
16. *Azolla*-choked ditch June 2007

This ditch was completely covered with *Azolla* during 2007 but with no treatment was clear in 2008 and just occasional plants have been seen since. *Azolla* does not appear to be a persistent problem here.
